Incident Report

Machine Type: Overhead Traction

Conditions: New Construction/Testing

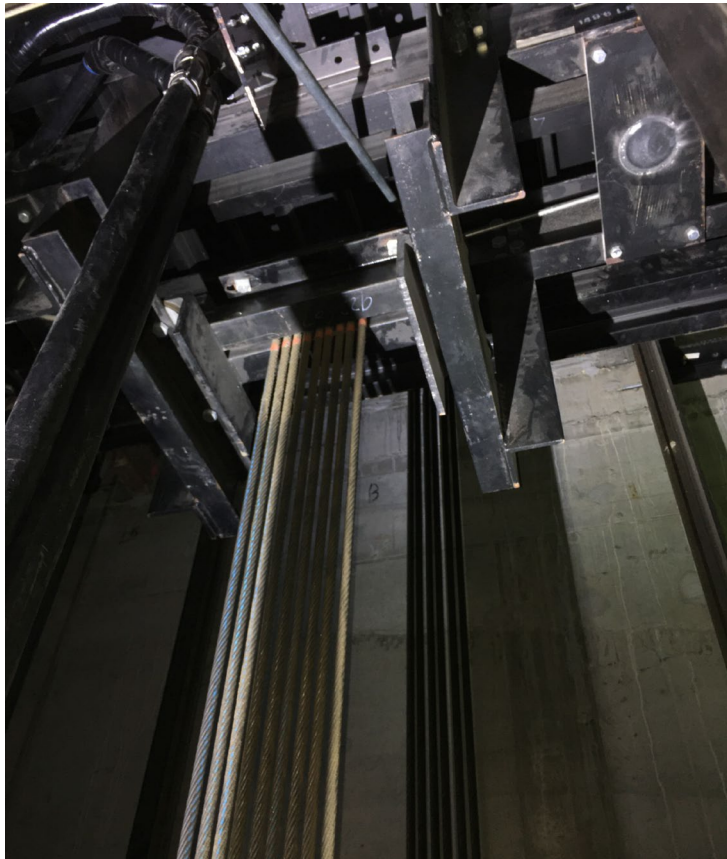
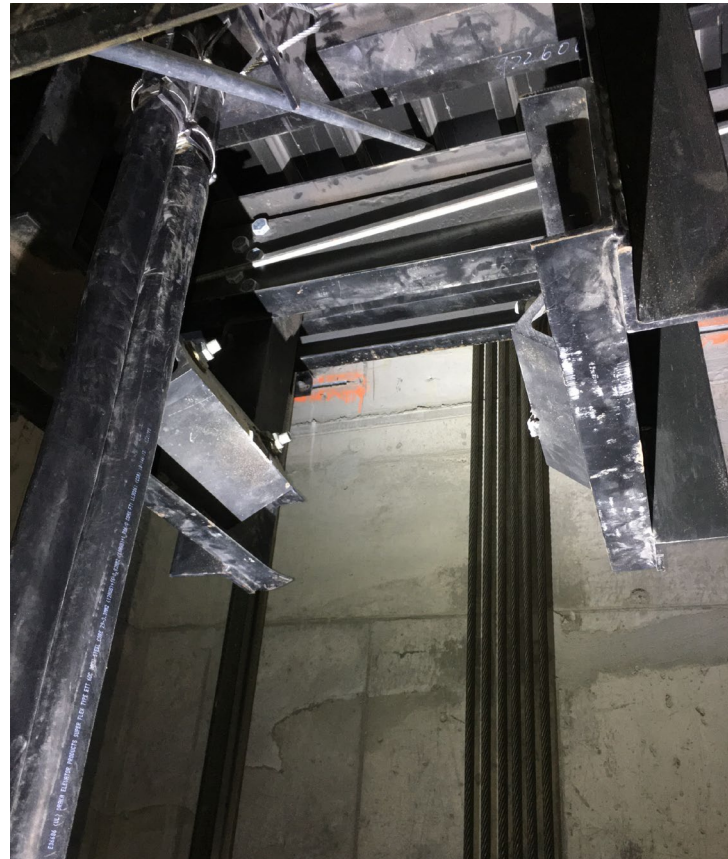
- An Adjuster and his Apprentice were performing a new construction temporary safety test.
- The car was loaded with 3,000 lbs. of test weight at the 131st floor. The Adjuster was in the machine room and the Apprentice was at the top floor with the chase car.
- The car was run down at 1250 fpm and the governor was tripped to engage the safeties. The safeties engaged and brought the car to rest at approximately the 121st floor.
- The compensation rope hitch underneath the car separated from the steel angles and channel and fell to the pit, 121 floors below. There were nine 11/16" comp. ropes.
- The comp. ropes bent rails, ripped out rail brackets, hoistway screening, limits, door locks, bent buffer platform and headers.
- Miraculously no one was injured.

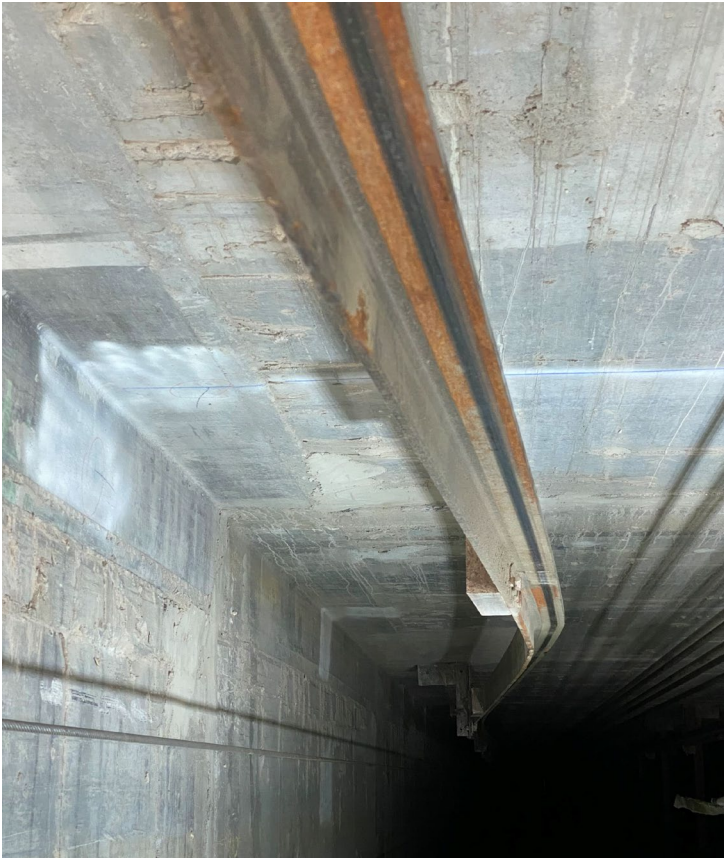
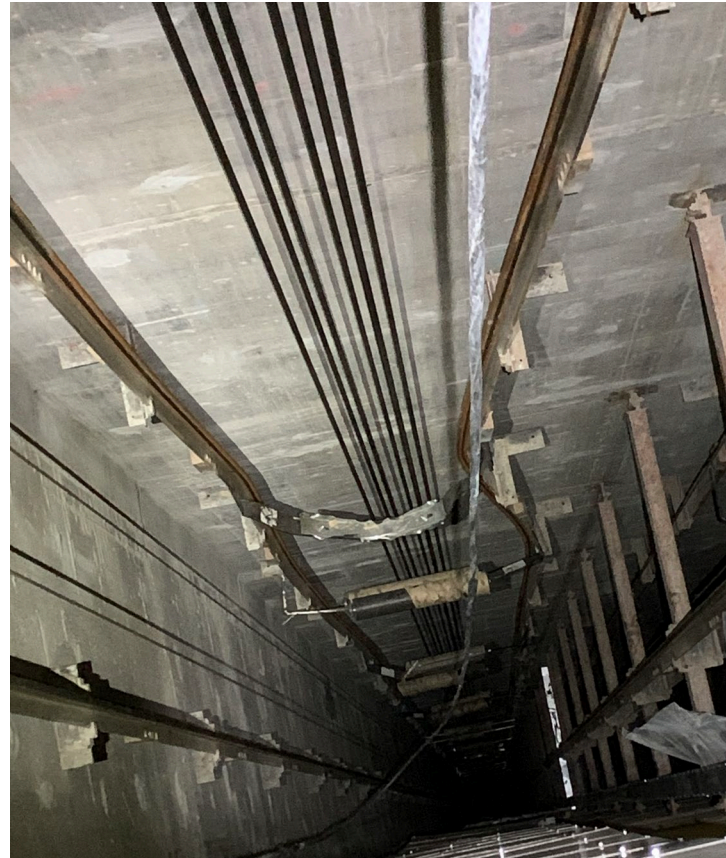
- Always perform a JHA.
- Be sure to follow manufacturers recommendations for installation of equipment.
- Follow company procedures and standard work processes for testing and adjusting.
- The span between the angles and channel was possibly too great for the compensation hitch beam. There was not enough support to hold the weight of the compensation block/hitch and ropes.
