IUEC INCIDENT SUMMARY

CLOSE CALLS, NEAR MISSES AND INJURIES

“CLOSE CALL”

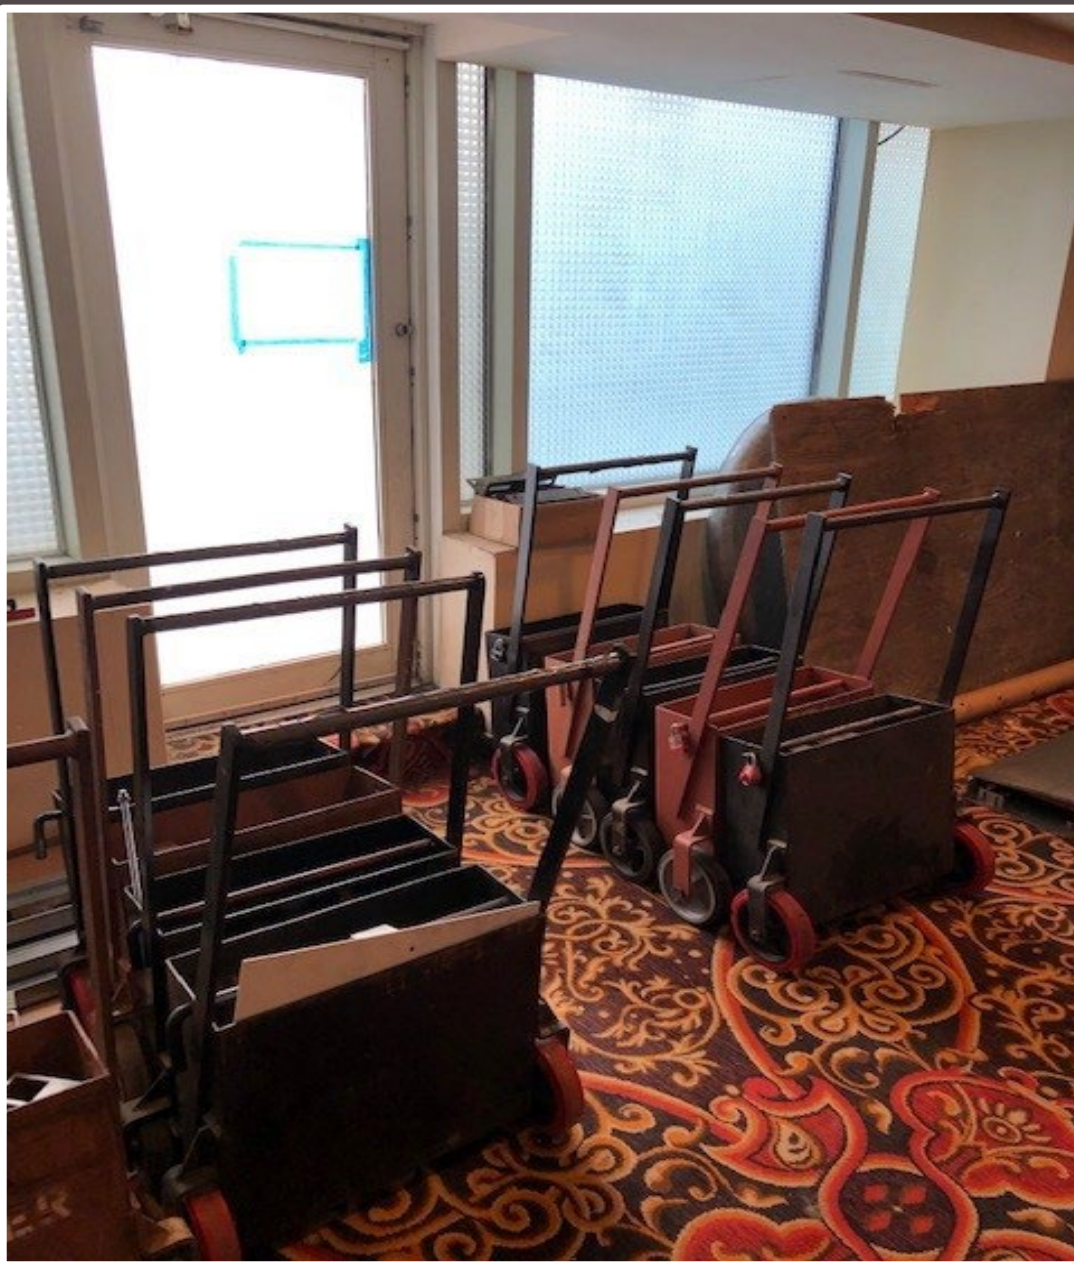
- Two crews were performing a modernization on two high speed gearless elevators.
- One elevator is of corner-post construction and was scheduled to have a full cab replacement on Saturday. The crews left the car on the 3rd floor loaded with 4500 lbs. of weights to counter balance the car which was stripped down to the platform, styles and crosshead.

- At the end of the day on Friday, prior to the cab replacement, one of the mechanics decided to remove the 4500 lbs. of test weights off the car platform.

- As he rolled the last weight cart off the platform, the car started to creep upwards. Within seconds, it overhauled and went up 38 floors into the overhead. The car wound up on its safeties in the overhead, the compensating sheave was ripped out of its tie-downs and had flipped upside down. The counterweight landed, compressing the buffer, and the traveling cables were ripped out of their hitches under the car. Luckily, no one was hurt.

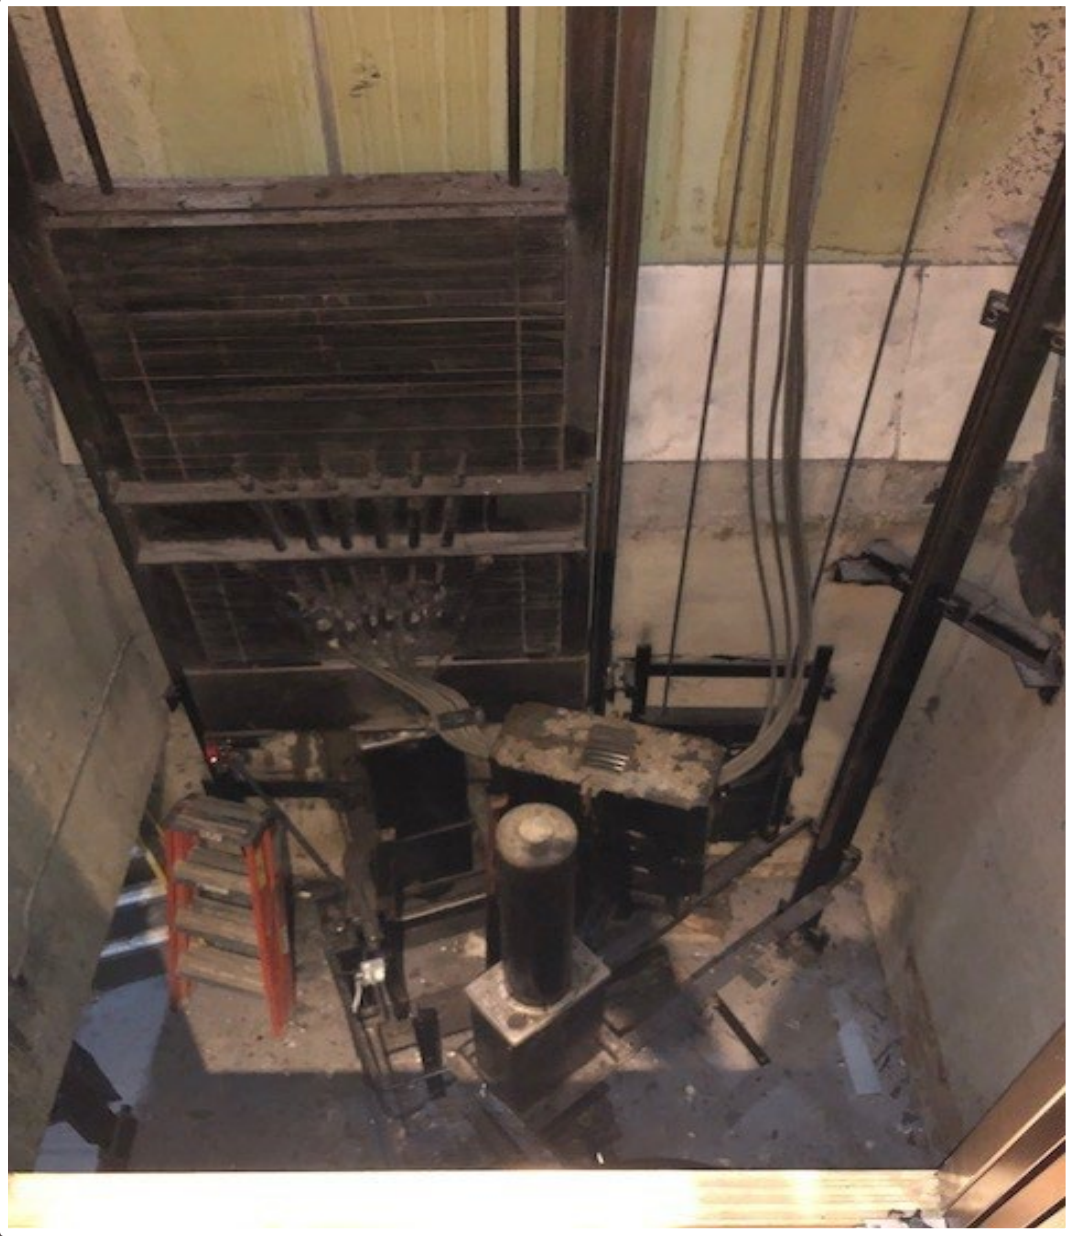
- Always follow the company safety policy
- Always perform a JHA/JSA as per company policy
- Always follow the company SOP
- Possible Root Causes:
 - Removing the weights from the platform was the root cause. Additionally, there were no secondary means of safety for this procedure such as rail grips or angles installed to the top of the car to prevent it from moving up. A rope gripper was also part of the modernization that had not yet been installed. If it was installed and operational, it could have prevented this incident from occurring

- (af) on modernization, when removing old material from elevator platforms, make sure counter balance is properly adjusted before proceeding.
