IUEC INCIDENT SUMMARY

CLOSE CALLS, NEAR MISSES AND INJURIES

“NEAR MISS”

April 28th 2023---IUEC Safety Stand Down Day

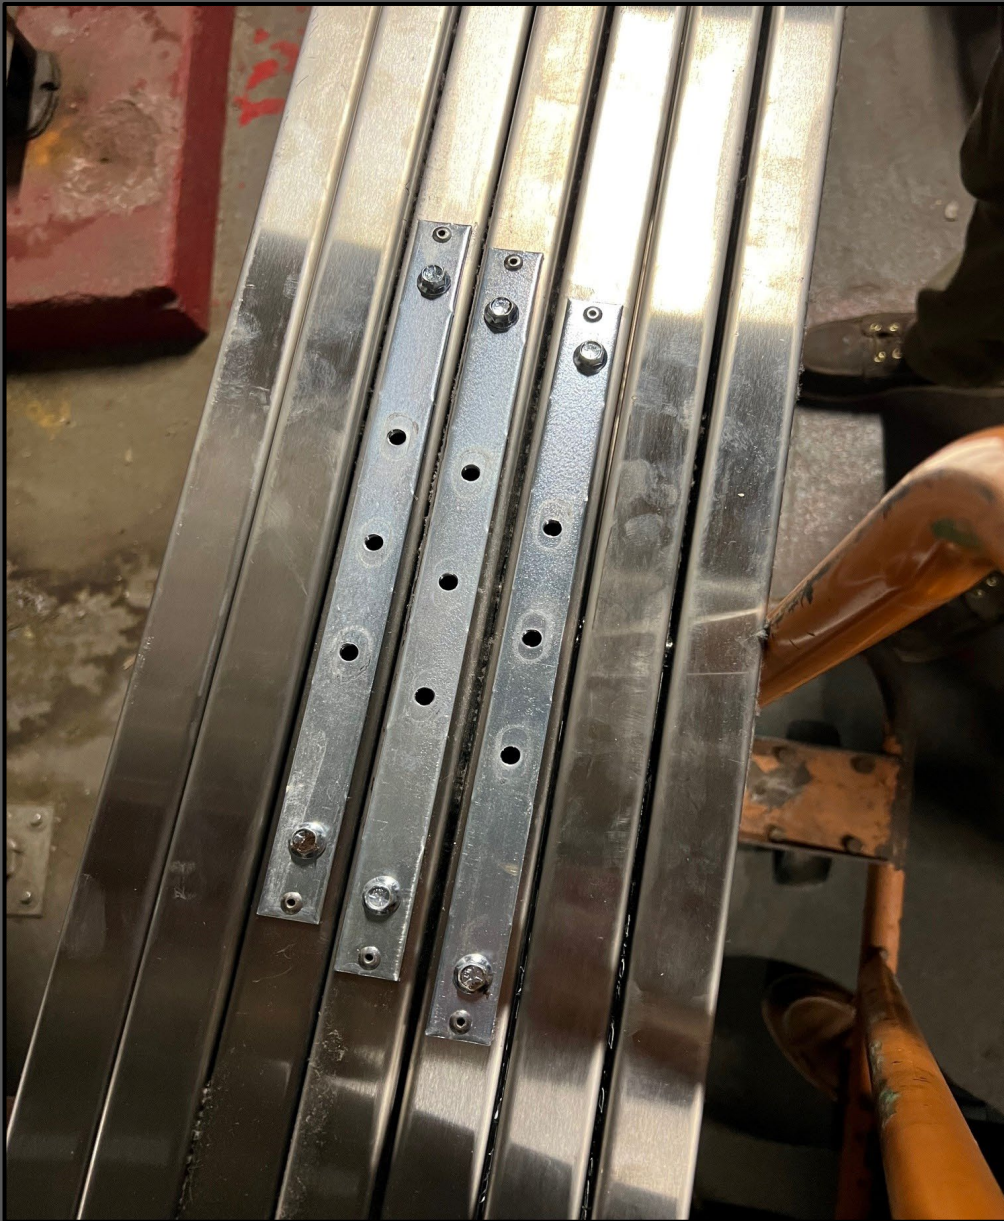
-
- A Modernization crew was working on the second car of a 2 car Mod job. The first car was completed by another crew, passed inspection, and was turned over to the hospital. While the second team was working on their car, they received a call from the hospital stating that the first car was running with the lobby doors open.
 - Upon inspection they found that the car was running with the slow speed door open. They discovered the GAL spring closer was detached and the slow speed door relating angle was not installed.
 - The doors were Peelle; two speed horizontal sliding doors
 - The doors had a plate that was tapped with three 5/16 holes to receive the GAL spring closer, and the plate was secured to the door by two pop rivets.
 - The rivets broke off and the bracket on the slow door became dislodged

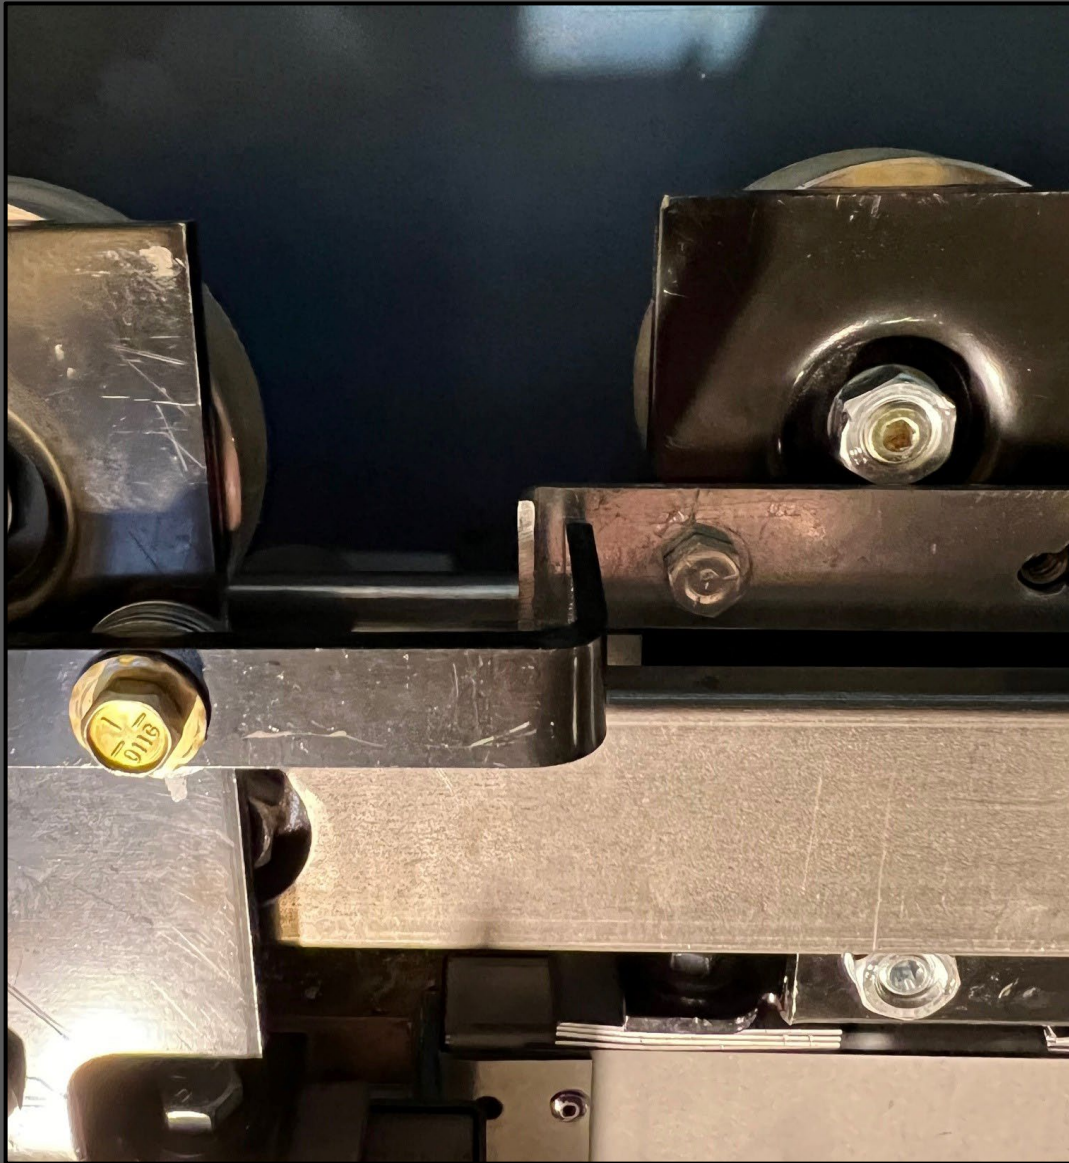
- Possible Root Causes:
 - The Peelle doors were not manufactured properly
 - The rivets attaching the GAL spring closer adaptor plate failed and the closer fell off the door
 - The relating angle was not installed on the slow speed door

- Current status:
 - Peelle was contacted and they replaced all of the slow speed doors. They put the adaptor plate with the three 5/16 tapped holes on the inside of the door and attached it with rivets.
 - The new slow speed doors have been installed and the relating angle has been installed on the slow speed door
