IUEC INCIDENT SUMMARY

CLOSE CALLS, NEAR MISSES AND INJURIES

April 28th 2023---IUEC Safety Stand Down Day

Incident Report

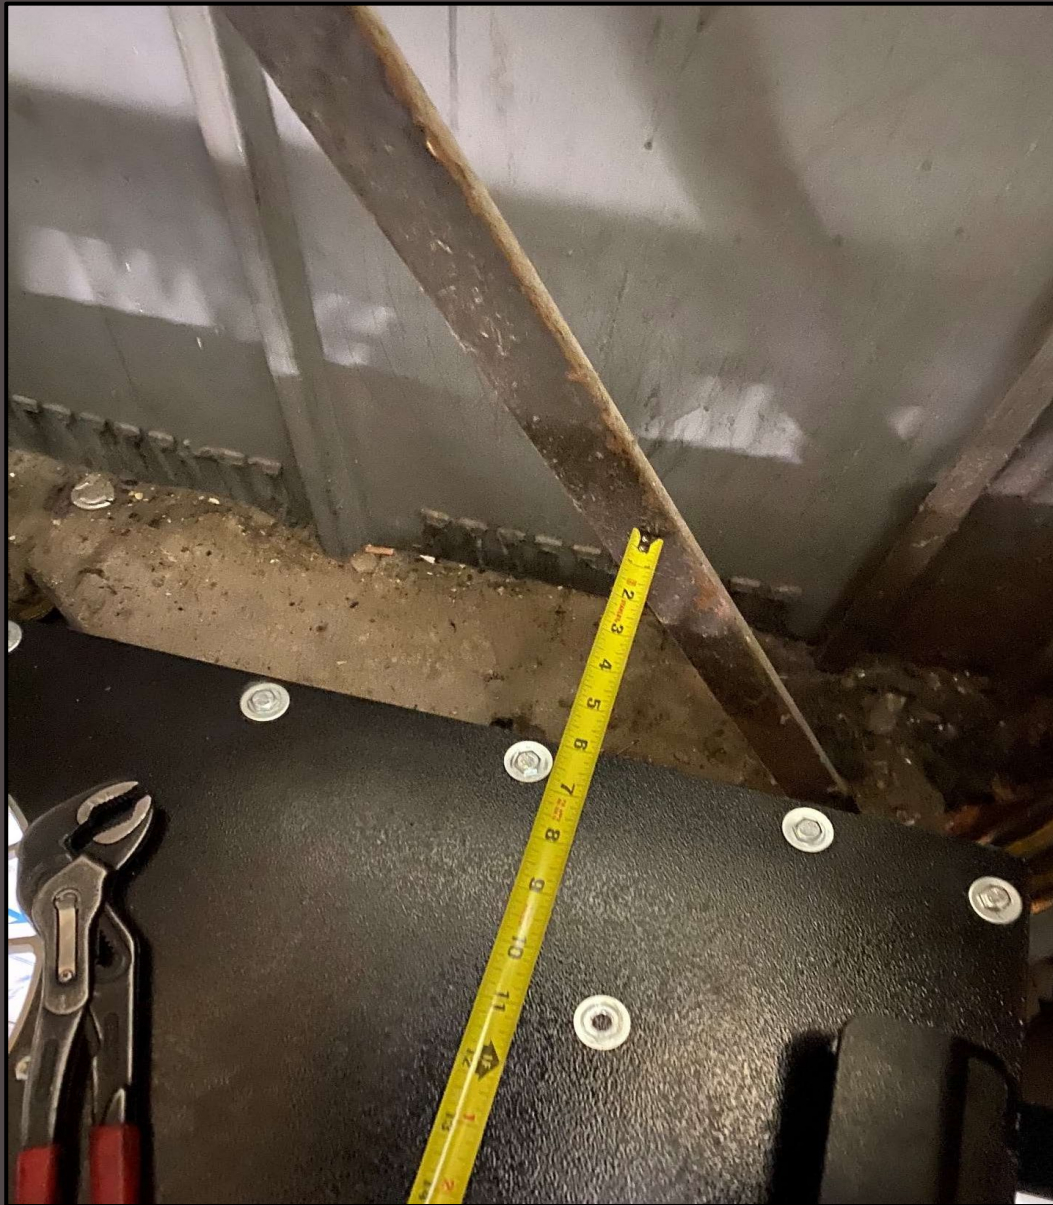
- A crew was installing a new cab on an elevator which is part of a duplex configuration. The cars have corner post rails, no divider beams, and 6 inches of clearance between the cars.
- The mechanic was working inside the car attempting to line up the new transom to the walls. The apprentice was on the landing leaning into the hoistway tightening the bolts on the newly installed transom and cartop.
- As the apprentice was performing his task, the adjacent car, which had not been taken out of service, came down to the 2nd landing (lobby floor) where the work was being performed.
- The adjacent car struck the apprentice in the back of his head; the impact caused him to hit his face on the elevator they were working on, leading to a laceration on his face.
