IUEC INCIDENT SUMMARY

CLOSE CALLS, NEAR MISSES AND INJURIES

“CLOSE CALL”

April 28th 2024---IUEC Safety Stand Down Day

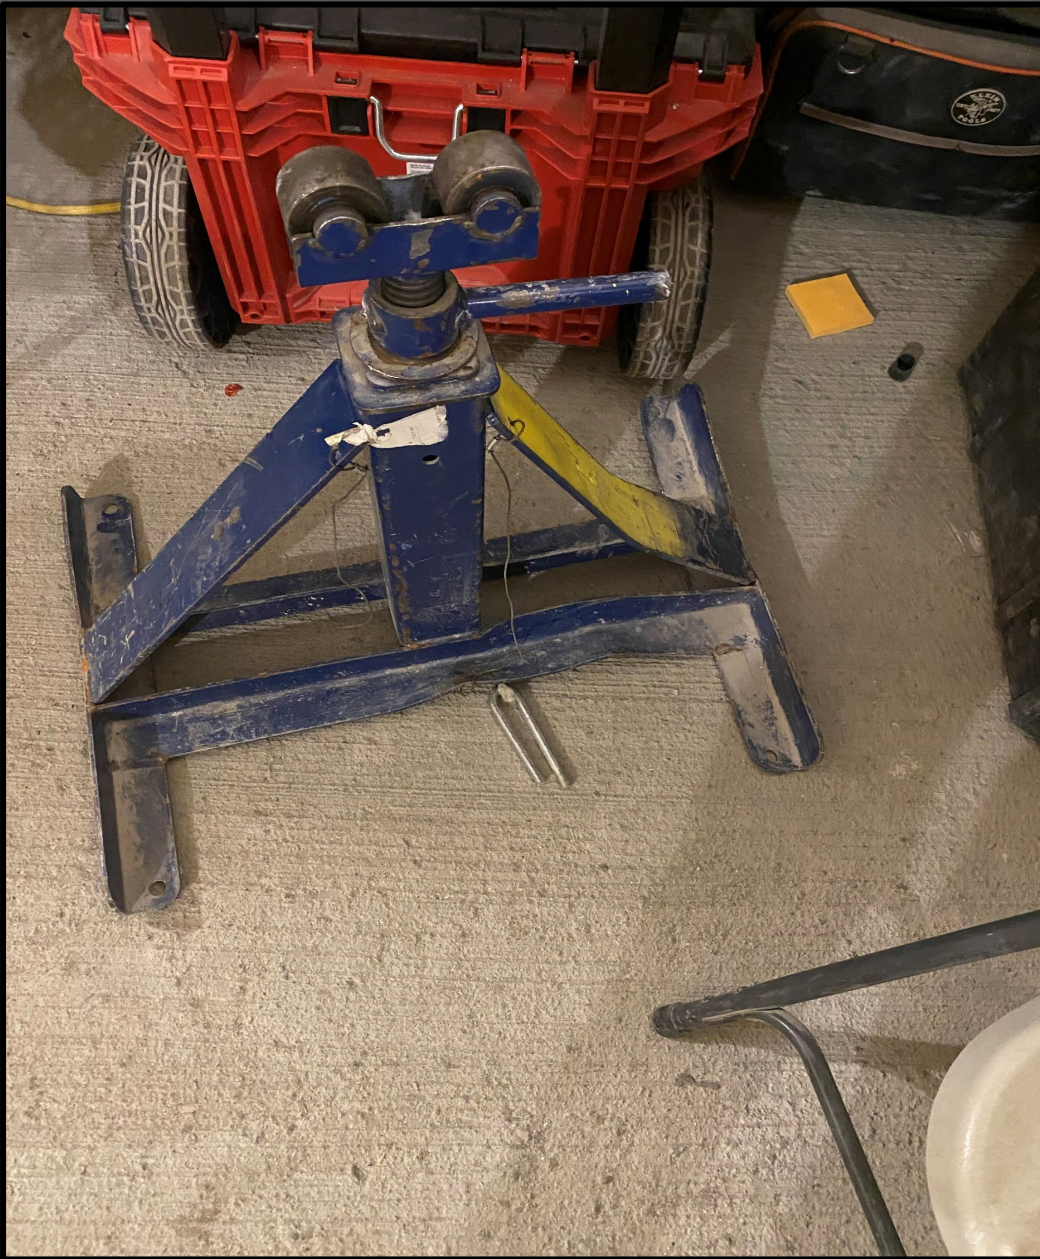
- A construction team was preparing to install a traveling cable from the 21st floor
- The traveling cable spool and reel stands were on the running platform, ready to run down. At this time, the team noticed that the traveling cable was going to reel off incorrectly.
- They lowered the travel cable spool down from the reel stands and began to spin the traveling cable to the correct position while they were on the running platform
- As they were repositioning the cable spool, one of the reel stands was knocked over and fell down the hoistway 21 floors

- There were no injuries, the team was using fall protection correctly, and proper PPE was worn by all members involved
- As the reel stand fell down the hoistway it damaged a rail bracket and a comp rope

- Always follow the company safety policy
- Always perform a JHA/JSA per company policy
- Potential hazards associated with rotating the traveling cable spool on the running platform at the 21st floor must be considered
- The team should have rolled the spool off the running platform, rotated the spool at the landing, and then rolled it back onto the running platform
