IUEC INCIDENT SUMMARY

CLOSE CALLS & INJURIES

INJURY

JANUARY 8, 2024

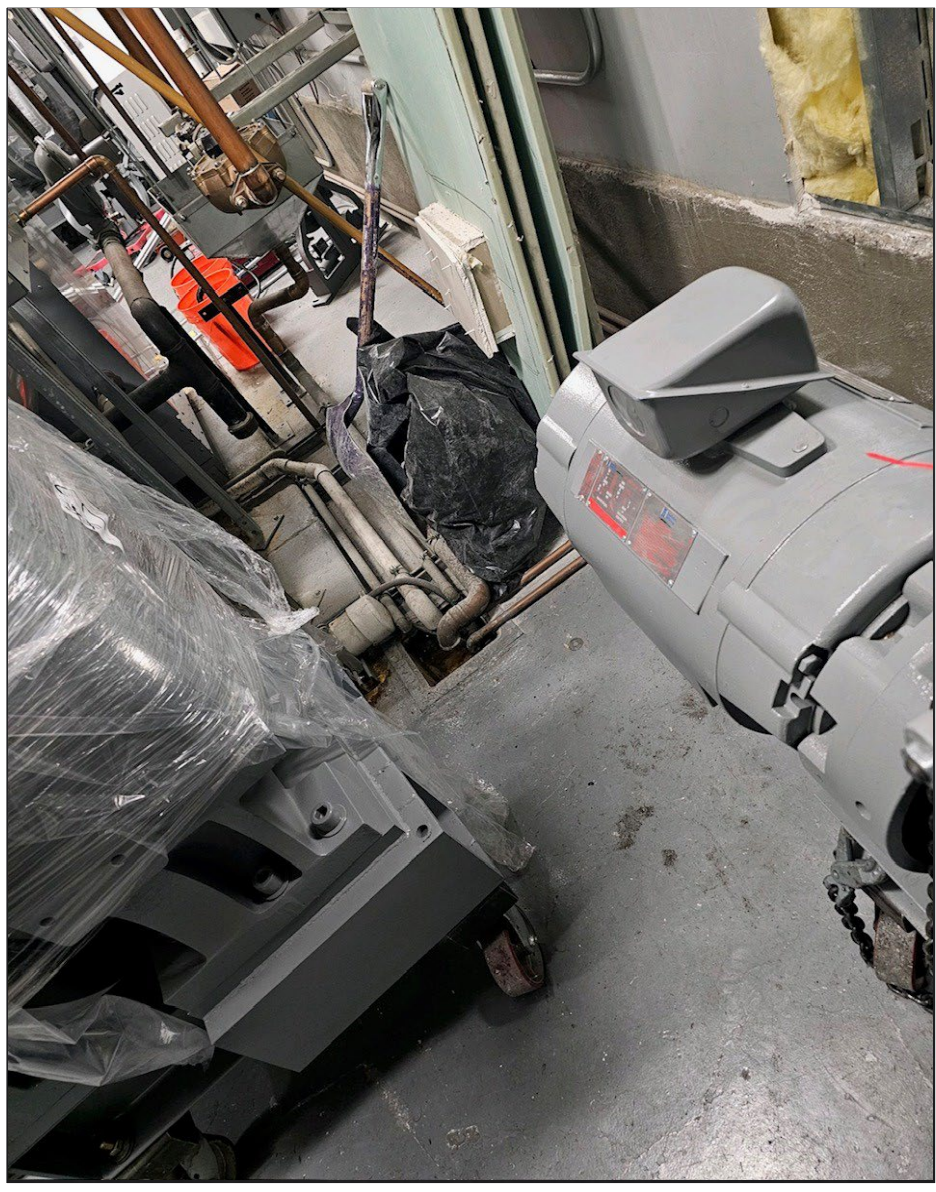
- A modernization team consisting of two mechanics were attempting to push a new geared machine that was mounted on casters to create more working space
- The mechanics first attempt to push the machine was unsuccessful
- The mechanics repositioned themselves to use additional force to move the machine on the second attempt. The machine moved faster than anticipated pinching one mechanic's middle finger between the moving machine and another stationary machine.

The injured mechanic received 14 stitches in his middle finger and the tip of his finger was broken. He was released to return to work the next day with the restriction to not use his injured hand and follow-up with a visit to an orthopedic surgeon in two days.

- No JHA/JSA performed
- The casters may not have been aligned with the direction of travel
- The mechanic's hand was improperly placed to avoid pinch points

- Always follow the company safety policy
- Always perform a JHA/JSA as per company policy

- (a) Handling of all heavy materials requires considerable care. Never use shortcuts.
- (b) Pay particular attention to the position of fingers and feet when using rollers, pinchbars, jacks and blocking to move heavy materials and equipment
