IUEC INCIDENT SUMMARY

CLOSE CALLS & INJURIES

INJURY

MAY 22, 2024

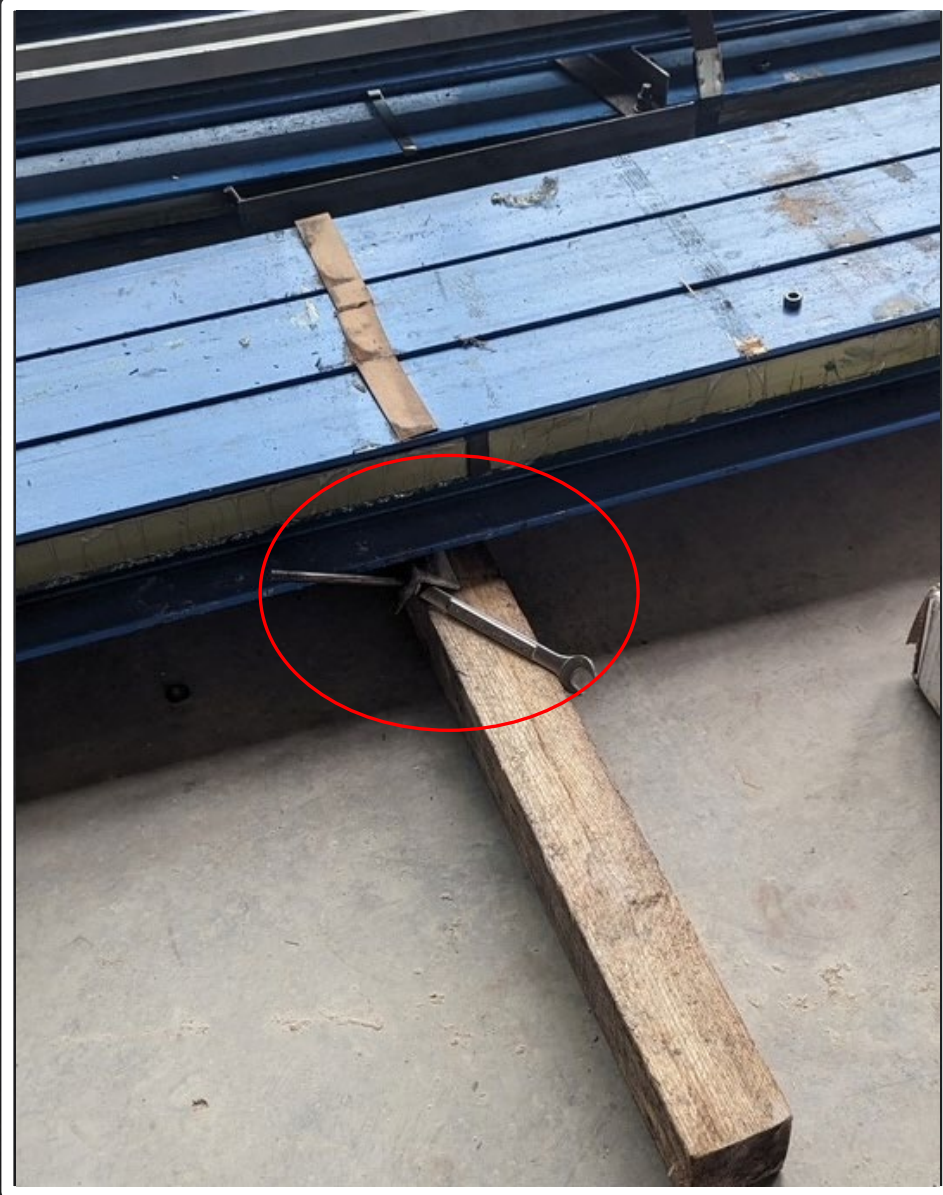
- An apprentice was disassembling the bolts and angle iron used to secure a bundle of rails for shipping
- When the nut was removed from the bolt, the rails shifted, and his finger was crushed against the wood blocking supporting the bundle of rails.

The apprentice's finger was broken, placed in a splint, and he has returned to work

- Improper blocking of the material
- Unfamiliar with the type of shipping containment

- Always follow the company safety policy
- Always perform a JHA/JSA as per company policy
- Always follow company Standard Work Processes

(b) Pay particular attention to the position of fingers and feet when using rollers, pinchbars, jacks and blocking to move heavy materials and equipment.

(f) When placing blocking and cribbing, be sure to have ample bearing surface. Never stack the timber in such a manner that maneuvering the load could cause it to tip.
