# IUEC INCIDENT SUMMARY

CLOSE CALLS & INJURIES

INJURY

SEPTEMBER 3, 2024

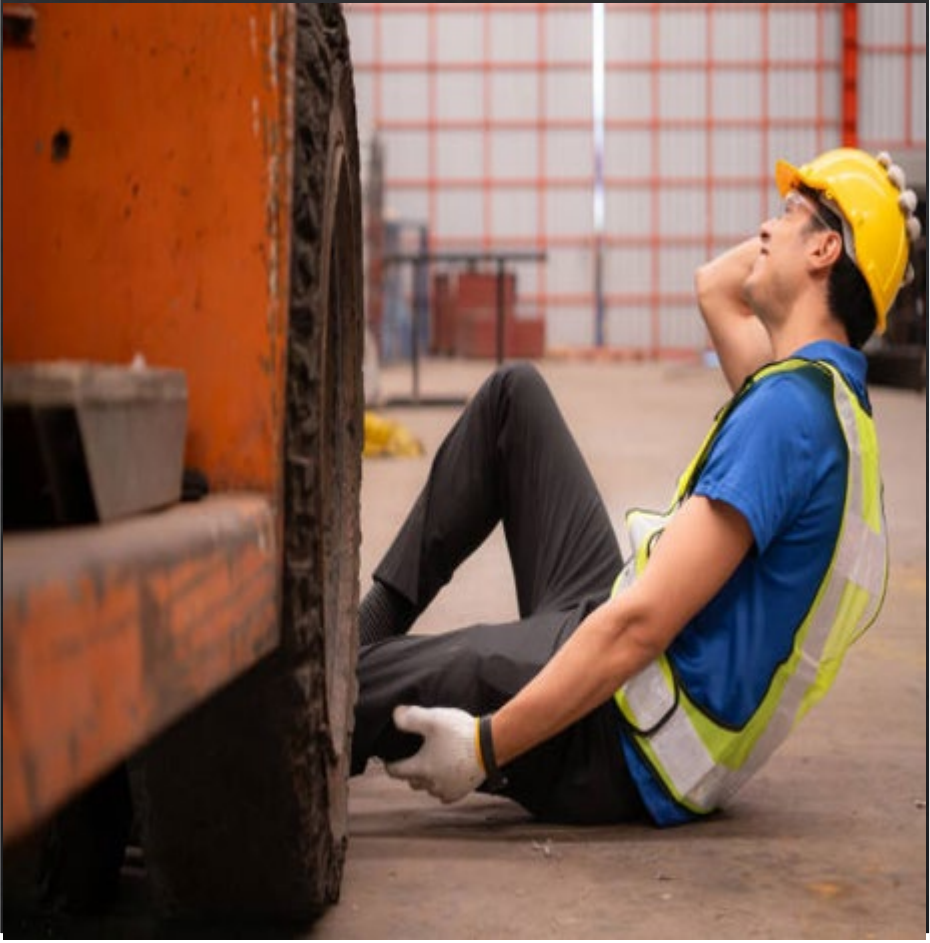
- Two mechanics used a forklift to transport hoisting and rigging equipment to the top floor of a parking ramp
- After discussing the next steps of installation, one mechanic started to walk back to the hoistway as the other was beginning to return the forklift to the lower level
- The walking mechanic turned around and approached the forklift from behind to give the mechanic further instructions
- The mechanic operating the forklift did not see the other mechanic approach and when he turned the forklift, the rear tire ran over his foot

The mechanic will be out of work for several weeks recovering from a fractured ankle

Photograph is for representational purposes only

- Not establishing proper communication protocols

- Always follow the company safety policy
- Always perform a JHA/JSA as per company policy
- Never approach a vehicle from behind when it is in operation
