# IUEC INCIDENT SUMMARY

CLOSE CALLS & INJURIES

INJURY

OCTOBER 24, 2024

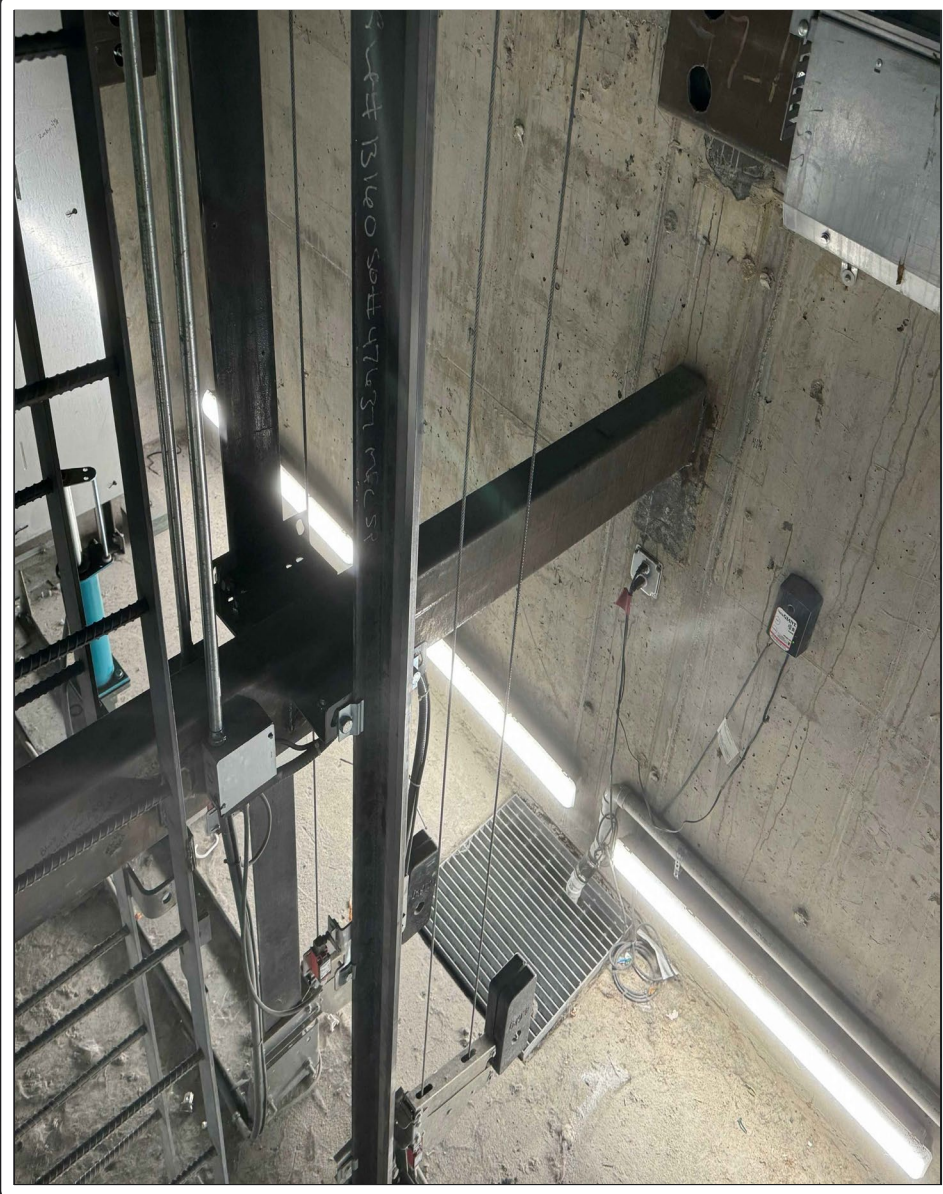
- Two maintenance mechanics were installing hold down brackets for filler weights when a piece of hardware fell into the sump well of a duplex pit
- One of the mechanics tried to remove the metal grating from the well when the coupling for the sump pump discharge line failed and water began spraying onto the mechanic
- The mechanic repositioned himself to reach for the hardware and was struck by the rear entrance toe guard of the adjacent car, knocking him down and pinning him to the pit floor
- The second mechanic was able to move the car, secure it, and help the first mechanic out of the pit and to the hospital

- The sump well cover was not properly installed requiring disassembly of the discharge line for removal
- Failure to control both elevators when accessing a shared space

- Always follow the company safety policy
- Always perform a JHA/JSA as per company policy
- Separation of Adjacent Pits
