# IUEC INCIDENT SUMMARY

CLOSE CALLS & INJURIES

INJURY

JANUARY 21, 2025

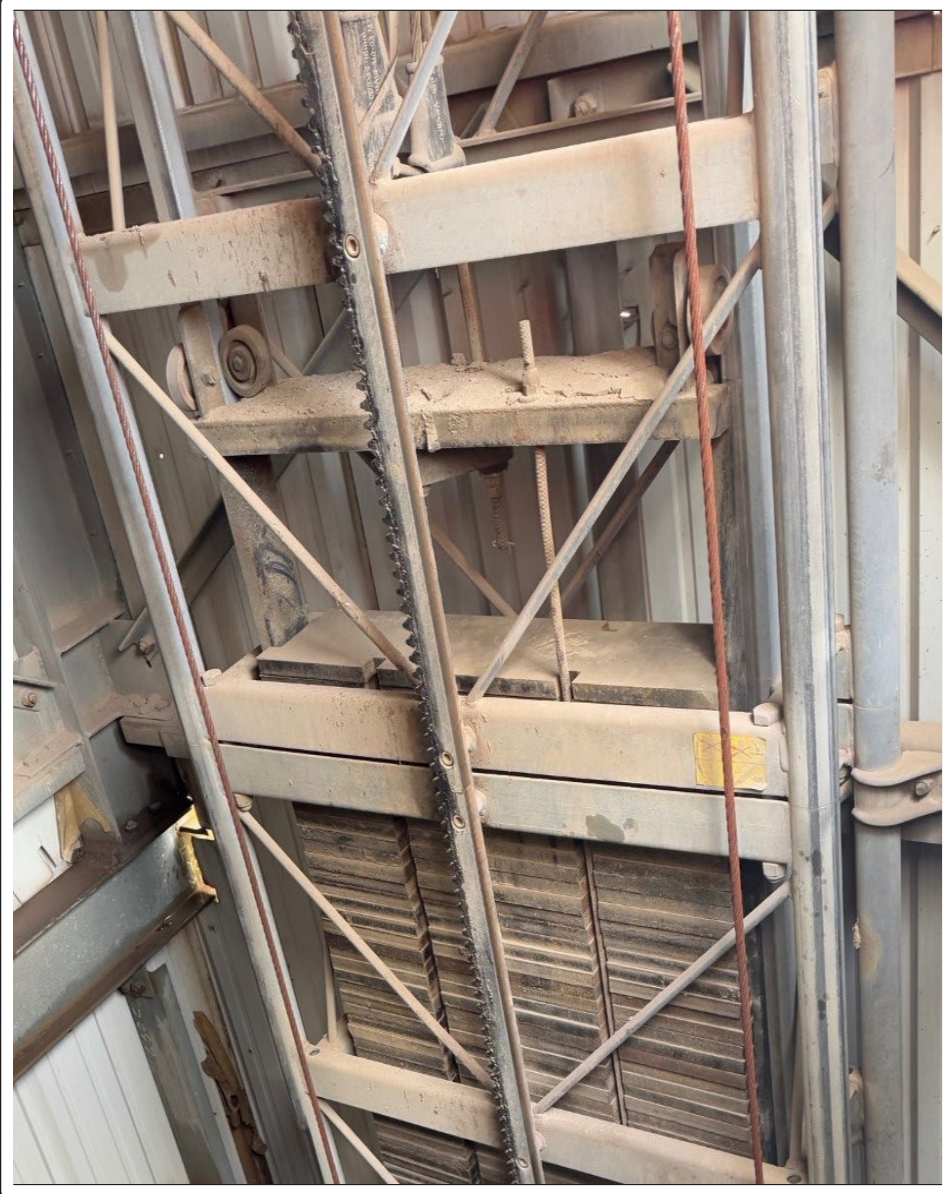
- 
- A mechanic and an apprentice were responding to a trouble call on a Rack & Pinion elevator and discovered the slack rope switch was tripped
  - The team accessed the cartop to manually lower the car and restore cable tension
  - As tension was being restored, they heard a noise from above. A filler weight from the counterweight frame had become dislodged, fell, and struck the apprentice.
  - The mechanic called for help and the fire department arrived to remove the apprentice from the cartop. The apprentice was medevacked to a nearby hospital

The apprentice suffered multiple severe injuries to his head, shoulder, arm, and torso and will have a lengthy recovery

- Filler weights not properly secured as required by code
- A filler weight from the counterweight frame dislodged and wedged between the counterweight and the tower frame
- The top weight section had been modified during installation by removing a tab meant to secure the weight section in the frame

- Always follow the company safety policy
- Always perform a JHA/JSA as per company policy

2.21.1.2 Weight sections are required to remain in place during buffer engagement or safety application and if they become broken.

2.21.2.6 Weights must be secured so that they can not shift to reduce the running clearances beyond those specified.
