IUEC INCIDENT SUMMARY

CLOSE CALLS & INJURIES

JANUARY 23, 2025

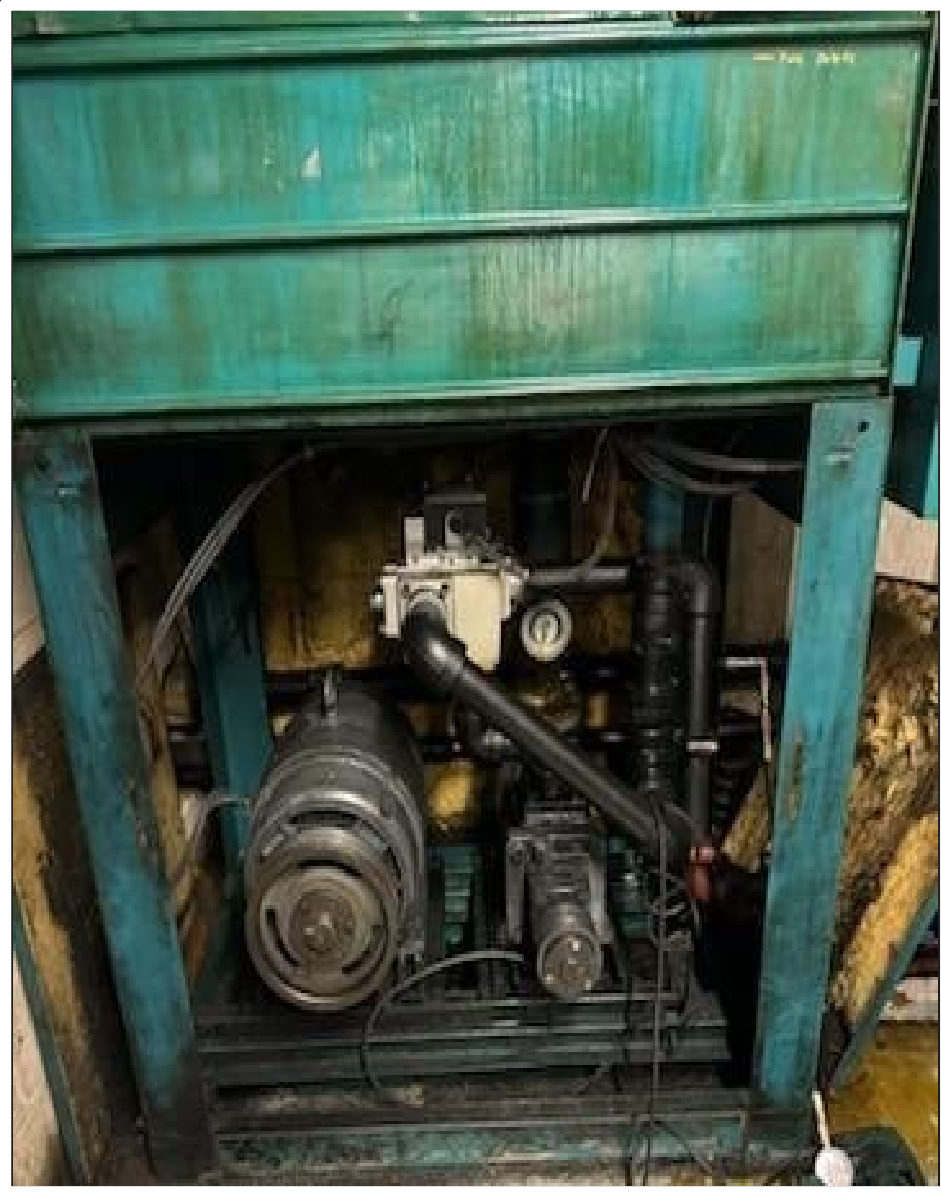
- While performing a Category 1 test, the mechanic noticed one of the pump motor V-belts was upside down
- The mechanic removed the elevator from service from within the controller and began to adjust the belt
- The elevator leaked down and when it releveled, the mechanic's hand was pulled in between the pulley and the belt

The tips of the middle and ring finger were amputated, and doctors were able to stitch the tip of the pinky finger in place to save it

Possible Root Cause:

- No Lockout and Tagout

- Always follow the company safety policy
- Always perform a JHA/JSA as per company policy

(b) Where the accidental starting of the equipment would create a hazard – deactivate mainline disconnect switch to shut off the power. **CAUTION:** Do not stand directly in front of the mainline disconnect when operating (stand off to the side of the disconnect). Each employee shall apply to the disconnect switch a personal lock and a “Do Not Start” tag with the employee’s name (Section 5.3).
