IUEC INCIDENT SUMMARY

CLOSE CALLS & INJURIES

INJURY

MARCH 17, 2025

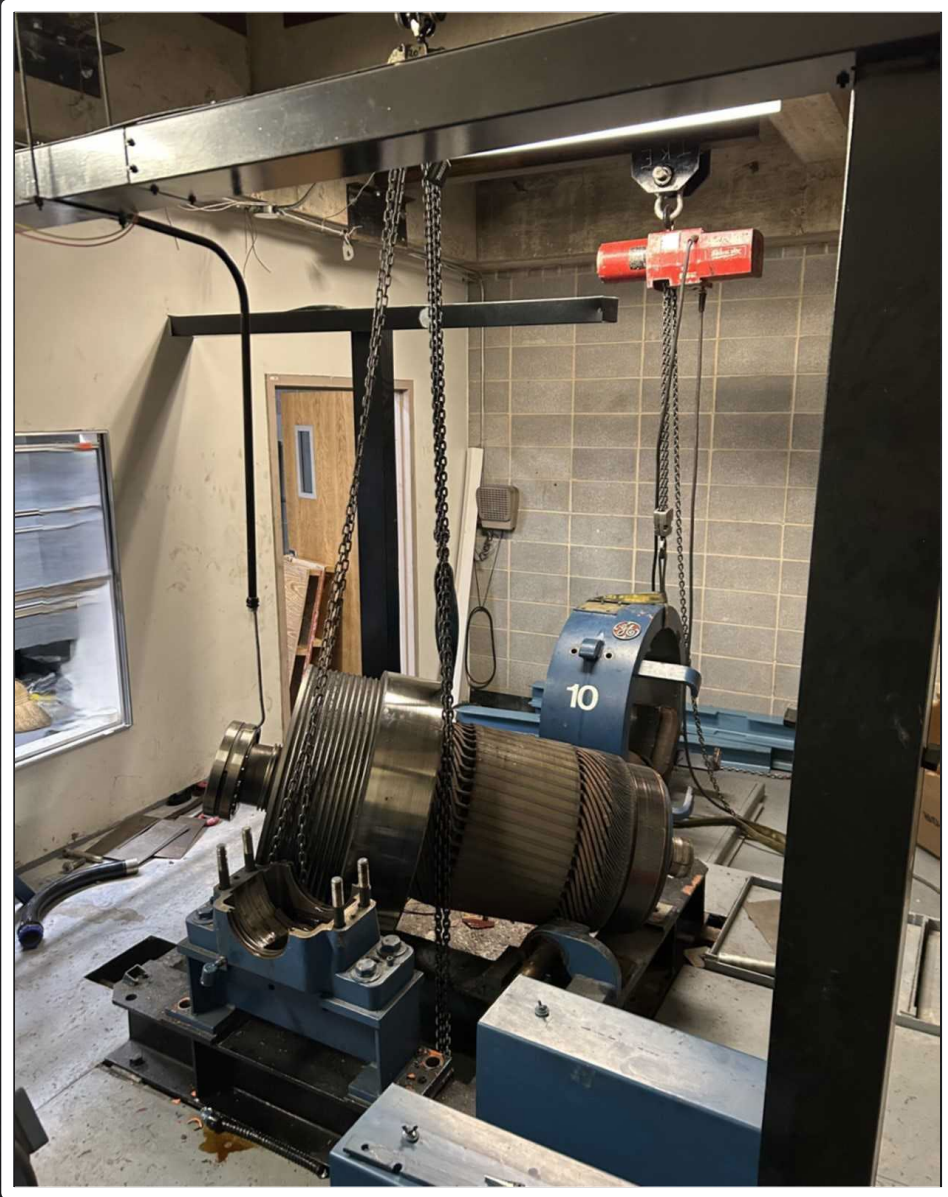
-
- A modernization crew was separating the motor armature from the frame to remove an existing gearless machine
 - The apprentice was holding a tag line attached to the frame suspended by chain falls
 - As the components were being separated, the frame broke loose pulling the apprentice towards the suspended equipment
 - The frame swung back towards the work area where the apprentice's leg was caught between the frame and the bedplate

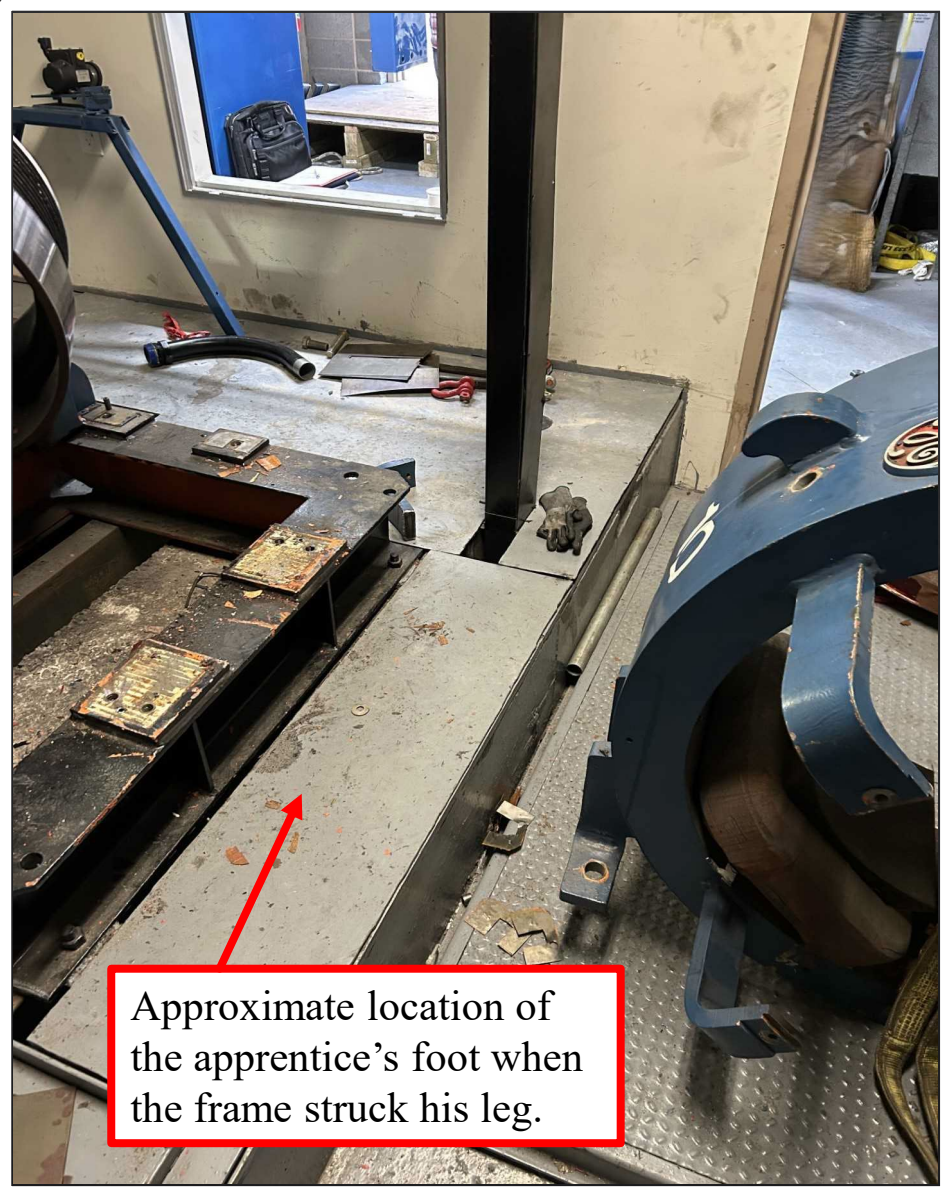
The apprentice suffered a fractured fibula and is performing light duty assignments during his recovery

- Rigging plan did not account for stored energy or an uncontrolled load

Approximate location of the apprentice's foot when the frame struck his leg.

- Always follow the company safety policy
- Always perform a JHA/JSA as per company policy

(b) Always stay clear of the load. Do not stand under the load. Know the weight of the load, the capacity of your equipment, the structure to which you are rigging and the overall condition of these items. Stand uphill or to the side of a load that's on a ramp.
