# IUEC INCIDENT SUMMARY

CLOSE CALLS & INJURIES

INJURY

OCTOBER 31, 2025

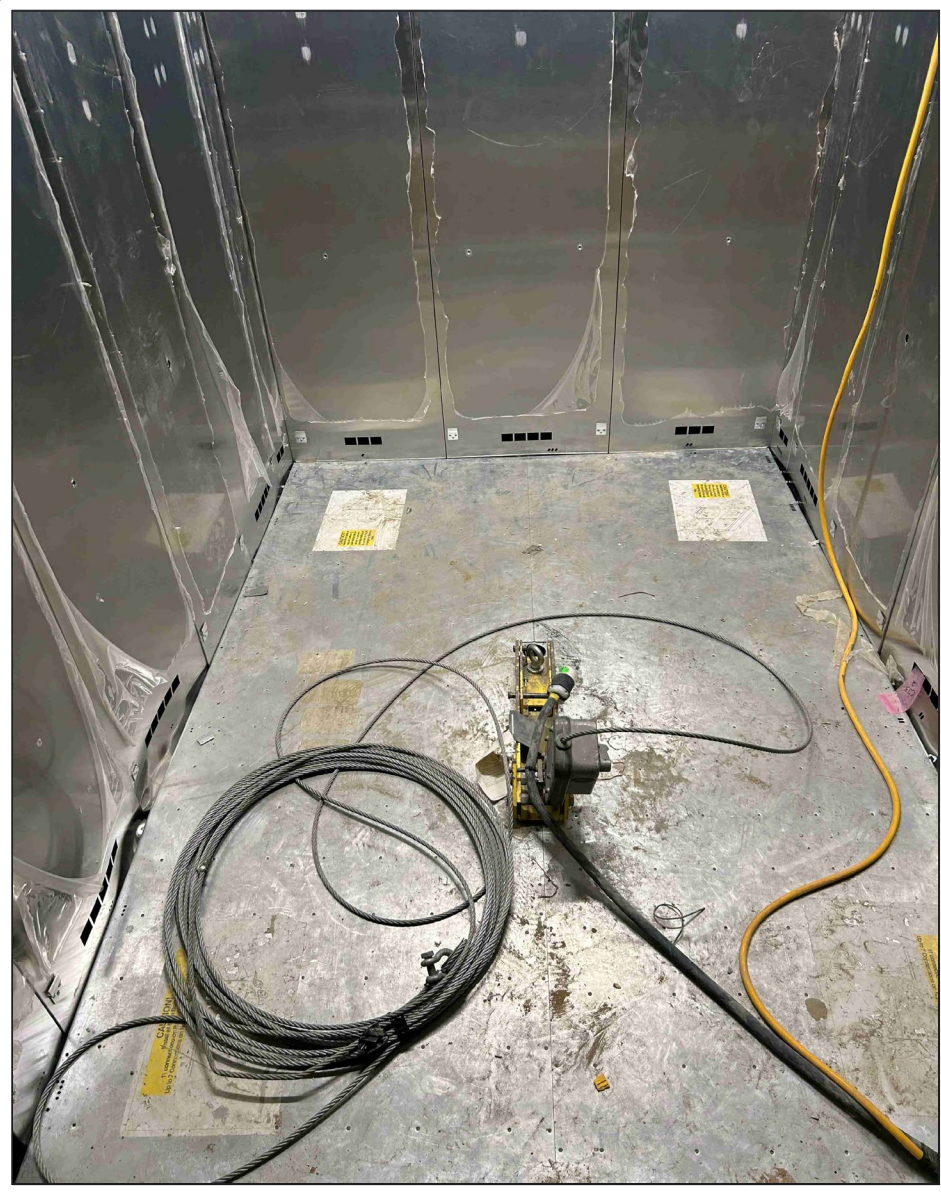
- 
- A mechanic and an apprentice completed the installation of CSBs on a new installation and were ready to remove the cable climbing system
  - They were coiling the temporary hoist cable onto the platform while traveling in the down direction
  - As they passed the midpoint of the hoistway, the belts started to lose traction
  - The car accelerated uncontrollably and crashed into the buffers

The mechanic suffered torn ligaments and tendons in his ankle, and the apprentice suffered a sprained ankle

- The governor rope was not installed at the time of the incident
- The running platform was improperly counterweighted

- Always follow the company safety policy
- Always perform a JHA/JSA as per company policy
- Always know the required counterweighting
- Never operate a moving work platform without operational safeties or an overspeed device

(c) The governor shall be installed and roped to the safety releasing arm and tested prior to operation

(e) When required, the running platform shall be counterweighted for the weight of the car platform assembly and its expected load. Counterweights shall be secured from bouncing or being lifted out of the frame.
