# IUEC INCIDENT SUMMARY

CLOSE CALLS & INJURIES

INJURY

MAY 5, 2026

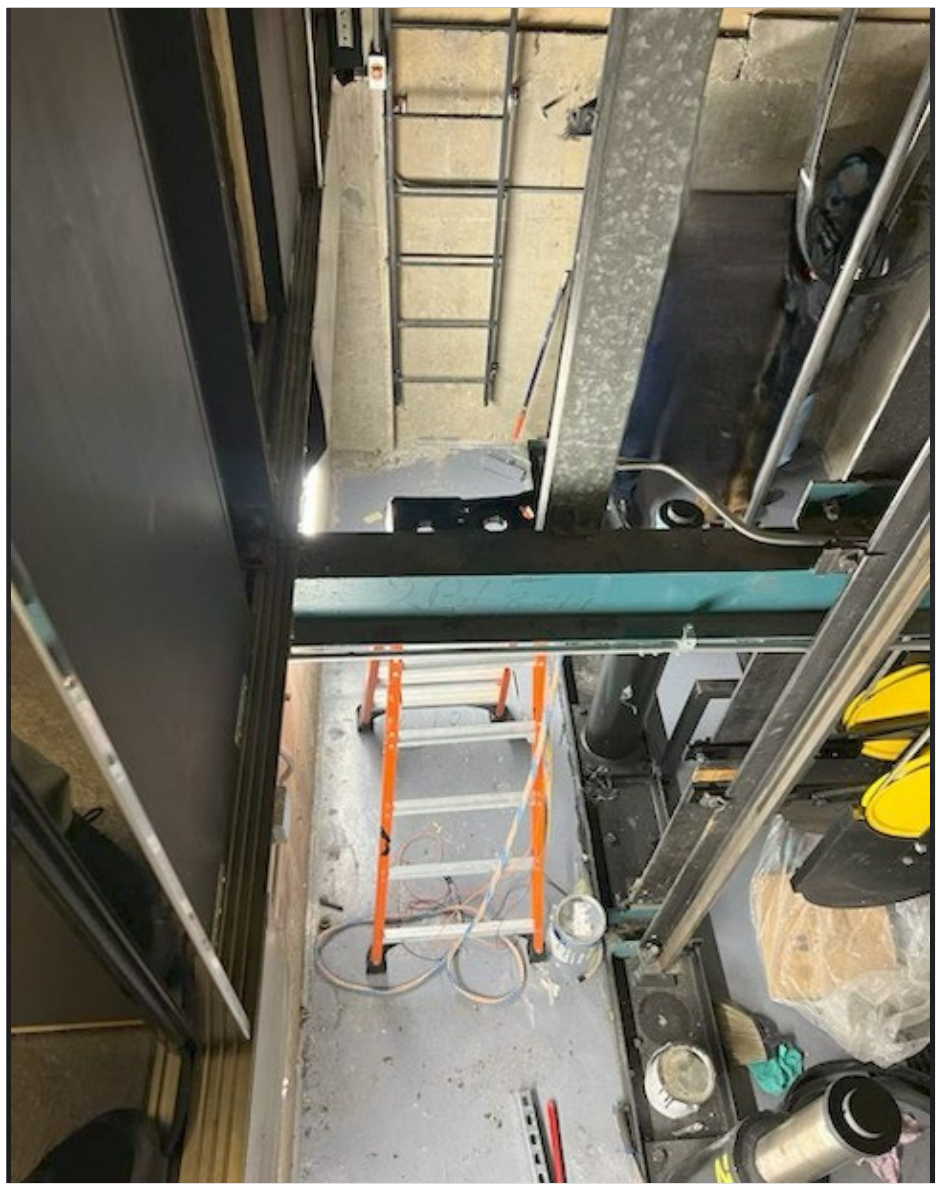
**Warning – Contains Graphic Image**

- The modernization crew parked car 1 on the 9<sup>th</sup> floor using Independent Service so they could work in the pit
- The apprentice was handing tools and materials from the 1<sup>st</sup> floor landing to the mechanic who was standing on an 8' step ladder in the pit
- The apprentice was instructed to close the hoistway doors and take car 2 to the top floor and get more wire connectors
- When the doors to car 1 closed the elevator went into Phase I Fire Recall and came down onto the mechanic trapping his arm between the car and hoistway sills before he could get off the ladder

Investigation found faulty wiring had caused the Phase I FS recall. The mechanic sustained severe injuries to his upper arm and remains out of work during a hopeful recovery

- The car being worked on should have been locked out and tagged out prior to beginning work

- Always follow the company safety policy
- Always perform a JHA/JSA as per company policy
- Never enter a hoistway without having complete control of the movement of the elevator

All forms of potential energy including electrical, mechanical, hydraulic, pneumatic, kinetic, gravity, etc. shall be controlled to prevent inadvertent movement of a unit or piece of equipment being worked on.
