# IUEC INCIDENT SUMMARY

CLOSE CALLS, NEAR MISSES AND INJURIES  
STRUCK BY INJURY

"INJURY"

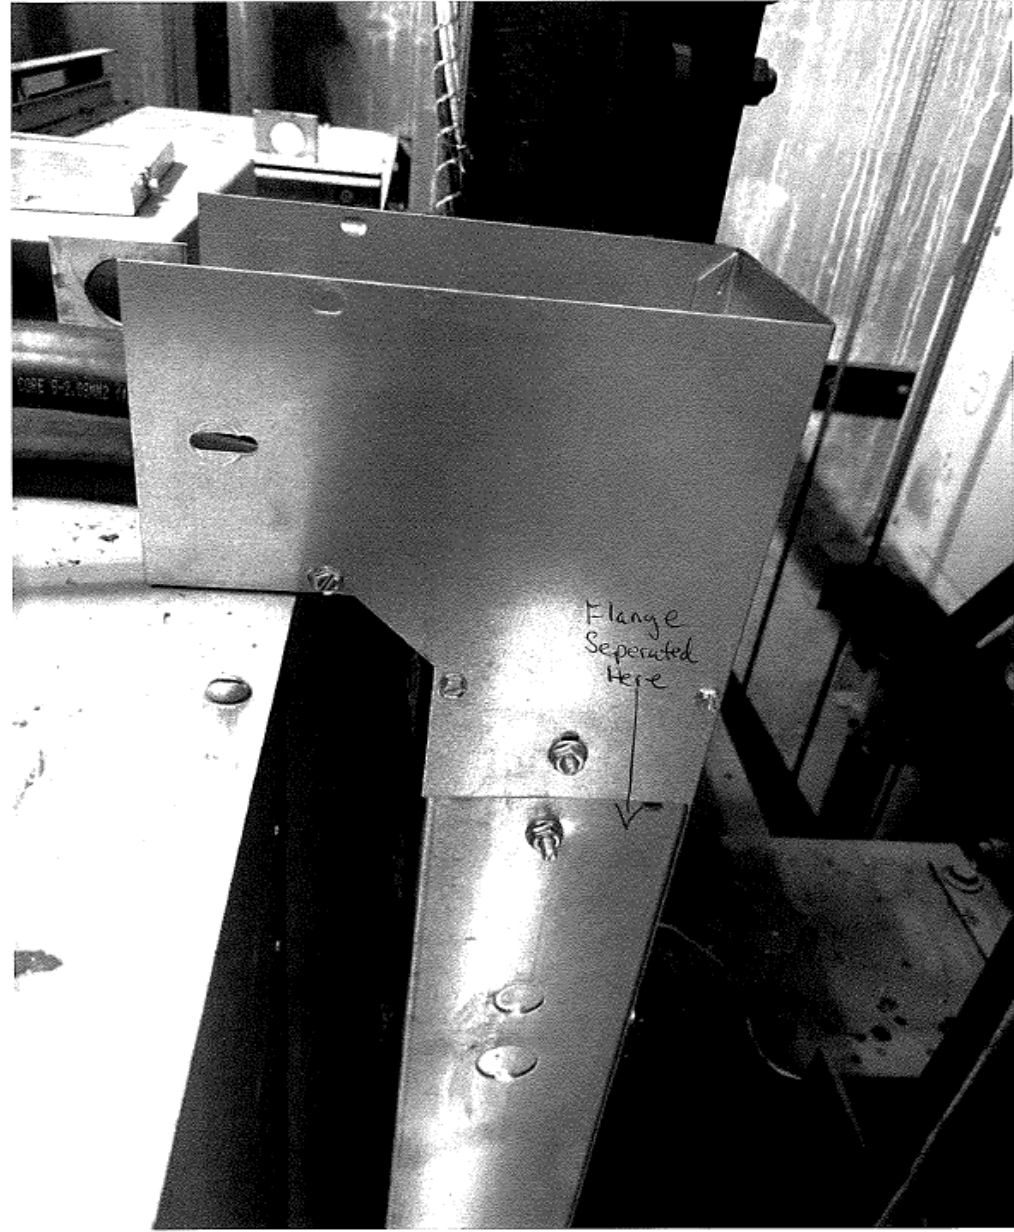
- A mechanic and an apprentice were hanging 4X4 duct on the side of the car for the traveler to pass through to the car top box.
- The manufacturer of the duct work is Draka.
- During the installation of the duct work, the spot welds broke which caused the duct to shift and fall while the Apprentice was holding it in place.
- When the duct fell it caused severe wrist lacerations down to the bone, severed tendons, veins and arteries, and fractured his wrist. The apprentice is currently recovering from surgery.
- The picture on the left shows the repairs to the duct work.
- As you can see, the repairs made on the job show that the duct is now drilled and through bolted to eliminate or reinforce the spot welds.

- Always follow the company Safety Policy.
- Always perform a JHA/JSA per company policy.
- Inspect all spot welds and if necessary, drill and through bolt them to hold the sections together.
- The General Duty Clause of the OSH ACT of 1970 is Section 5(a)(1) requirements:
  - Each employer shall furnish to each of his/her employees' employment and a place of employment which are free of hazards that are causing or are likely to cause death or serious physical harm to his/her employees'.
