IUEC INCIDENT SUMMARY

“INJURY-STRUCK BY”

April 28th 2023---IUEC Safety Stand Down Day

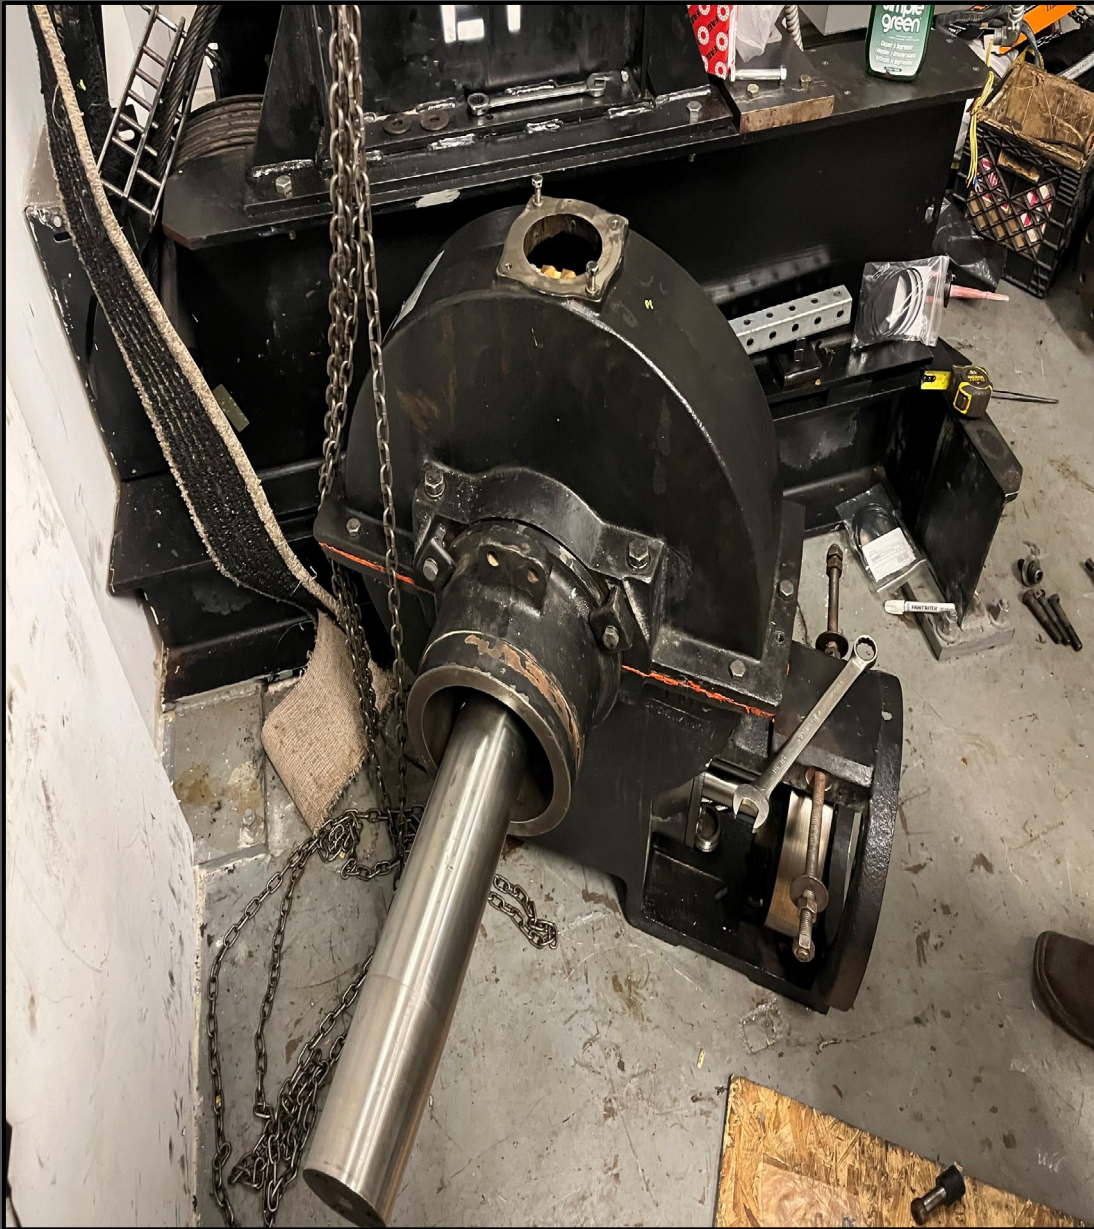
-
- A repair crew was sent to change out an inner bearing on a geared machine
 - After removing the old bearing they were trying to install the new bearing
 - In the process of installing the new bearing it became lodged in the housing. The mechanic and apprentice tried numerous methods to get the bearing out of the housing. They tapped on the front and back to free the bearing. They also used a bottle jack to try to push the bearing out of the housing to no avail.
 - While the apprentice was attempting to dislodge the bearing by tapping on the housing, the bearing fell out of the housing onto the mechanics hand resulting in a broken little finger and a laceration that required stitches.
 - Current Status:
 - The mechanic is back at work on light duty.

- Always follow the company safety policy
- Always perform a JHA/JSA as per company policy
- Always follow the MCP

- Field Employees' Safety Handbook
 - 12.3 Hoisting and Rigging
 - (a) The cardinal rules of hoisting are: stay clear of the load at all times, never stand under the load, know the weight of the load, capacity of your equipment, the structure to which you are rigging and the overall condition of these items. Stand uphill or to the side of a load that's on a ramp.

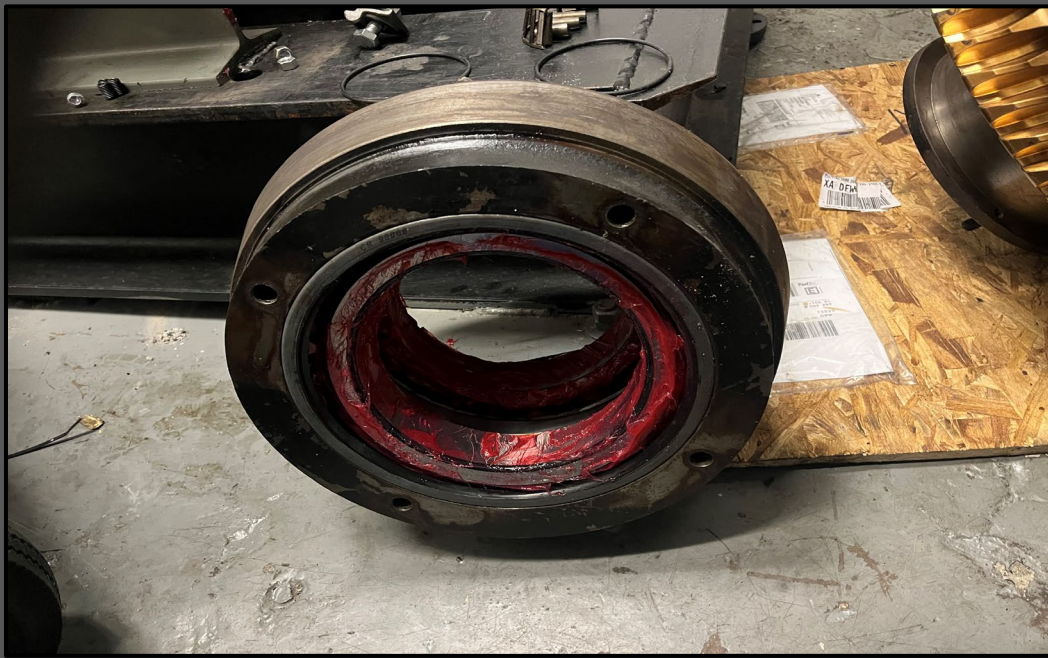
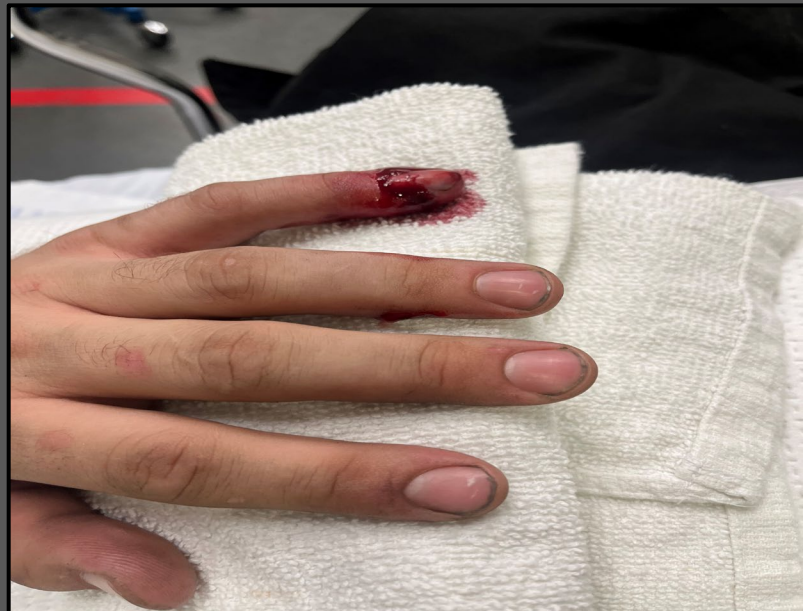
- Possible Root Causes:
 - Lack of situational awareness
