IUEC INCIDENT SUMMARY

“CLOSE CALL”

April 28th 2023---IUEC Safety Stand Down Day

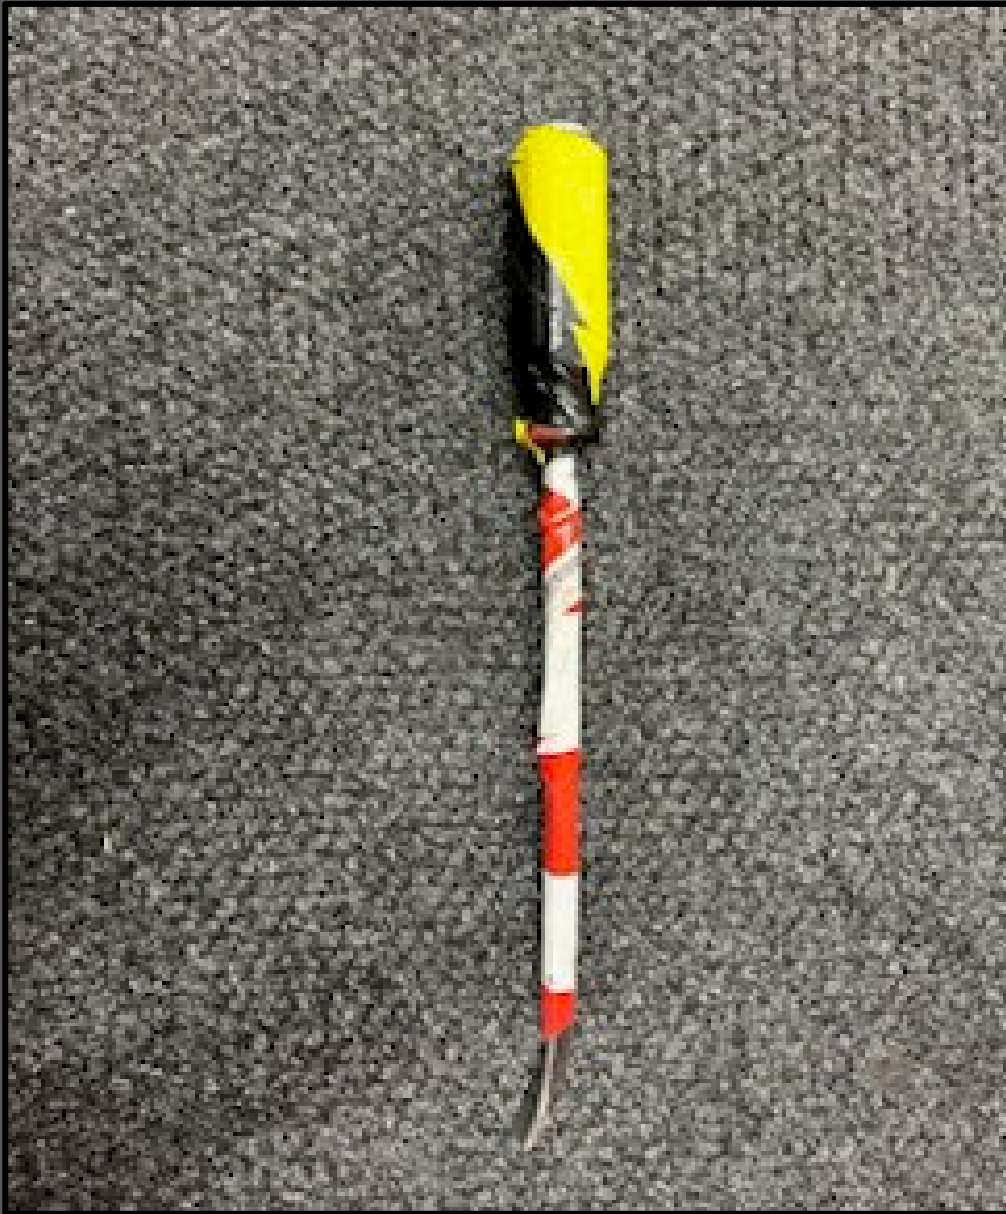
-
- Three modernization crews were working on a group of six elevators.
 - They started their day working in the pit. One crew was working the bottom roller guides of car 5 and the other two crews were installing a counterweight sheave on car 4.

- After lunch, one crew got on top of car 5 to adjust the roller guides and assumed the other two crews were in the machine room.
 - In fact, the other two crews had returned to the working platform in the pit of car 4 to continue the counterweight sheave installation. They thought the first team was still adjusting the bottom roller guides on car 5.

- The mechanic working on top of car 5 was using a pry bar to move the roller guide when the pry bar slipped out of his hand. He tried to grab the pry bar and as he leaned over the handrail, noticed the crews in the pit. He yelled “headache” as the pry bar hit the working platform of car 4.

- The apprentice working on the platform in car 4 pit had just left platform and the pry bar landed directly where he was standing.

- Always follow the company safety policy
- Always perform a JHA/JSA as per company policy

- JHA/JSA was not performed
- Hoistway screening for adjacent car protection not in place
- Safe work practices regarding stacked work and overhead protection not in place
- Poor communication

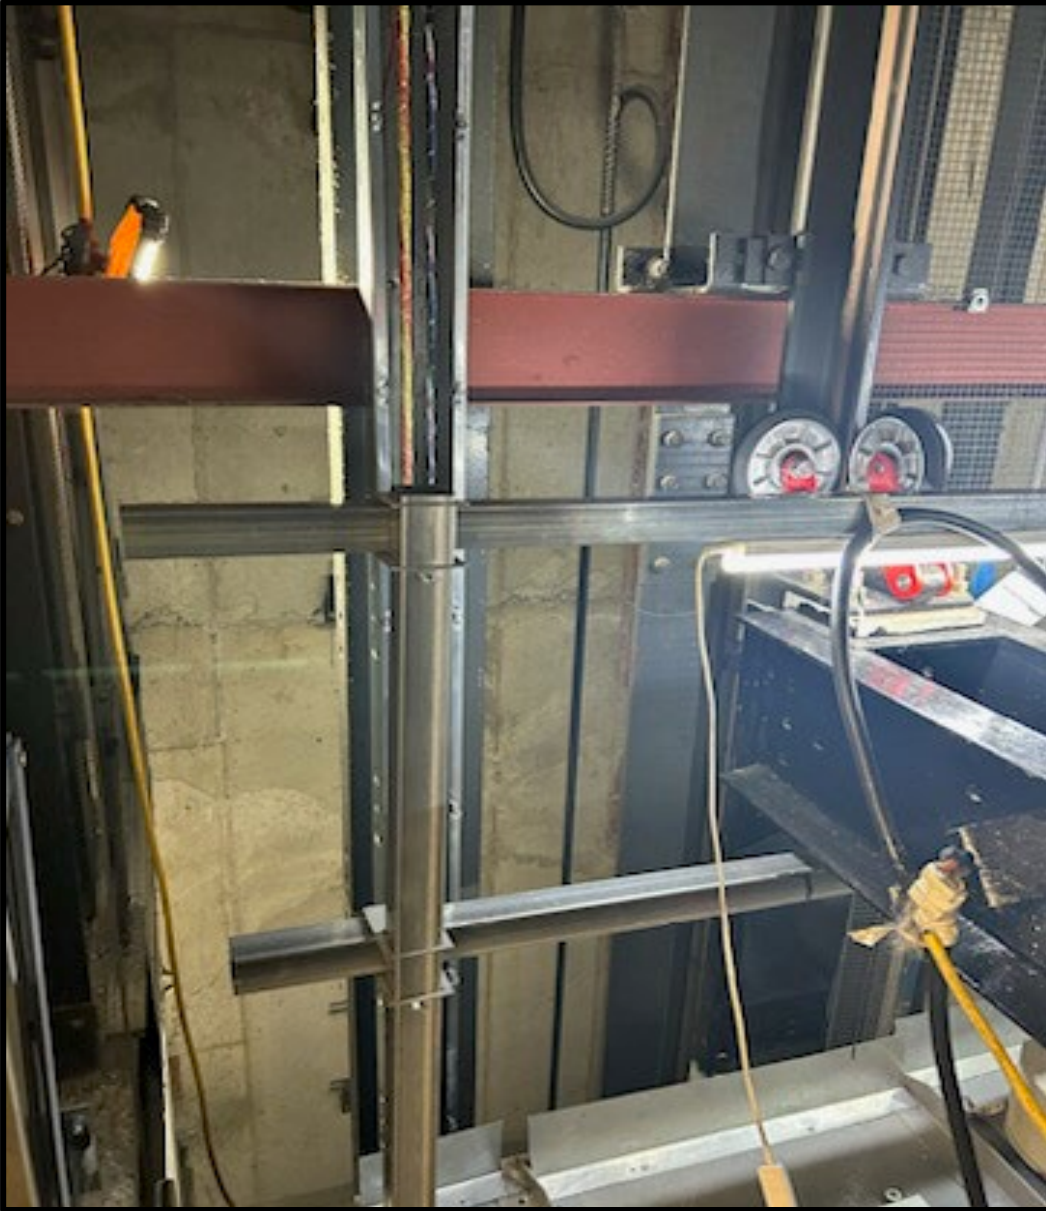
Where an elevator is operating in a multiple hoistway, and construction or modernization work is to be performed in an adjacent portion of that of the multiple hoistway, that portion of the elevators hoistway where the work is to be performed shall be fully separated. The material used for this separation shall:

- (a) be equal to or stronger than 0.0437 in. (1.118mm) dia. wire;
- (b) have openings not exceeding 1 in. (25 mm);
- (c) be so supported and braced so as not to deflect into the code required running clearance of the adjacent car: and
- (d) be in accordance with the local code.

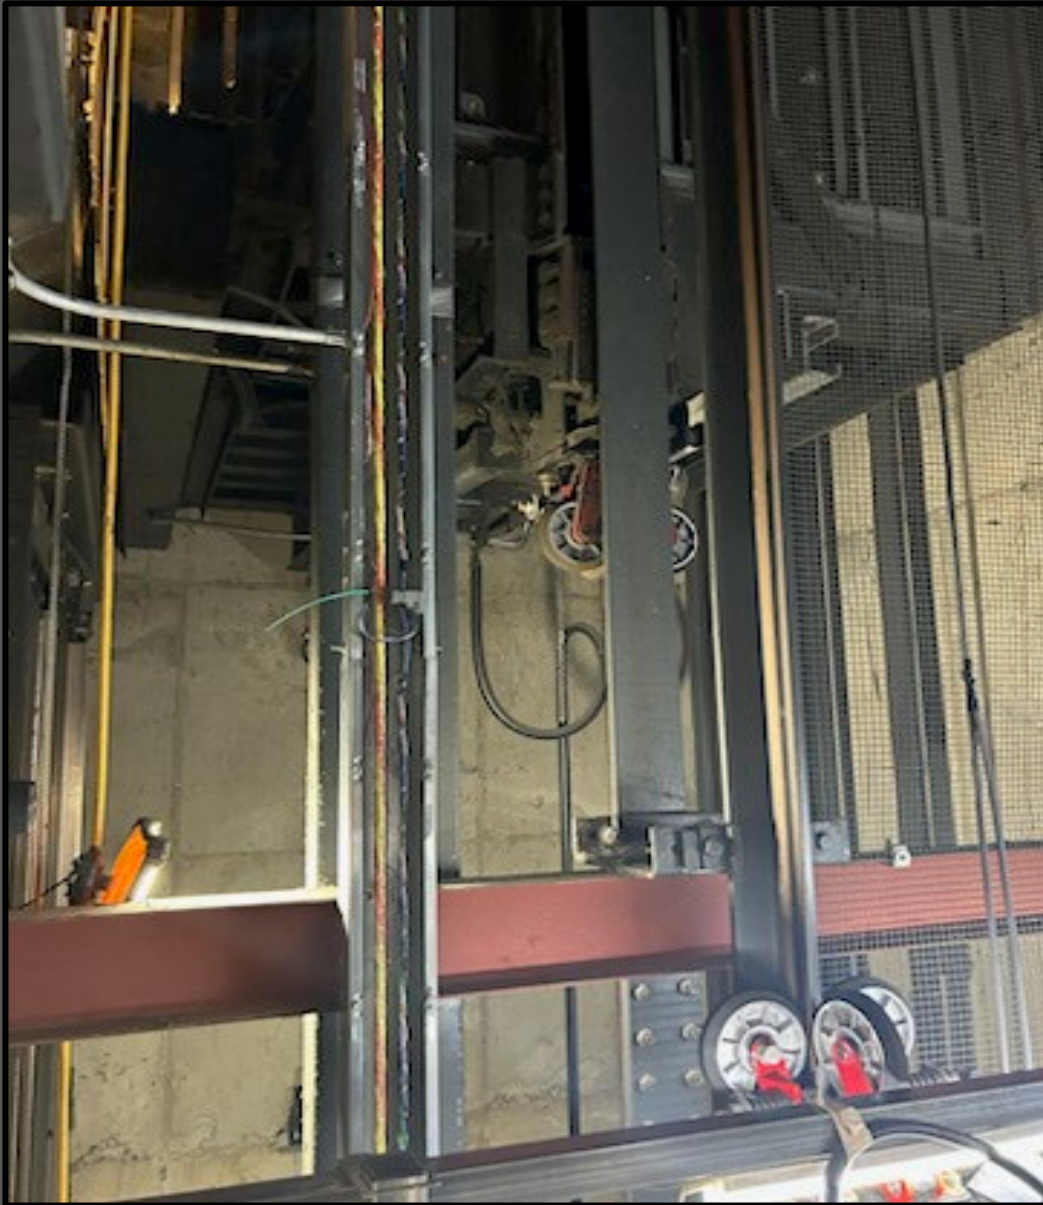
(a) Overhead protection shall be provided in the hoistway and in any other work area where there is exposure to falling objects. This protection is to prevent all parts of the body from being struck by falling tools, debris, small parts, etc.

(b) In general, overhead protection can be achieved by one or a combination of the following examples:

- (1) False cars with roofs/netting designed and selected by the company.
- (2) Installation of an overhead barrier directly above the work area which covers all areas where field personnel have to stand or reach to install hoistway components.
- (3) Protection of all hoistway openings above the work area (e.g.: installation of hoistway doors or protective screening).
- (4) Sealing off corridors to prevent other trades from working near or passing by wall openings.
- (5) Walls are in place and all hoistway doors closed.
- (6) Guarding all holes in the machine room and the secondary levels.
- (7) Prohibiting simultaneous work in hoistway and machine room with unguarded holes.
- (8) Prohibiting simultaneous work in common hoistways where no hoistway screening exists between hoistways.**
- (9) Prohibiting storage of materials within 6ft. (1.8m) of hoistway openings.
