# IUEC INCIDENT SUMMARY

CLOSE CALLS & INJURIES

“INJURY”

September 25, 2023

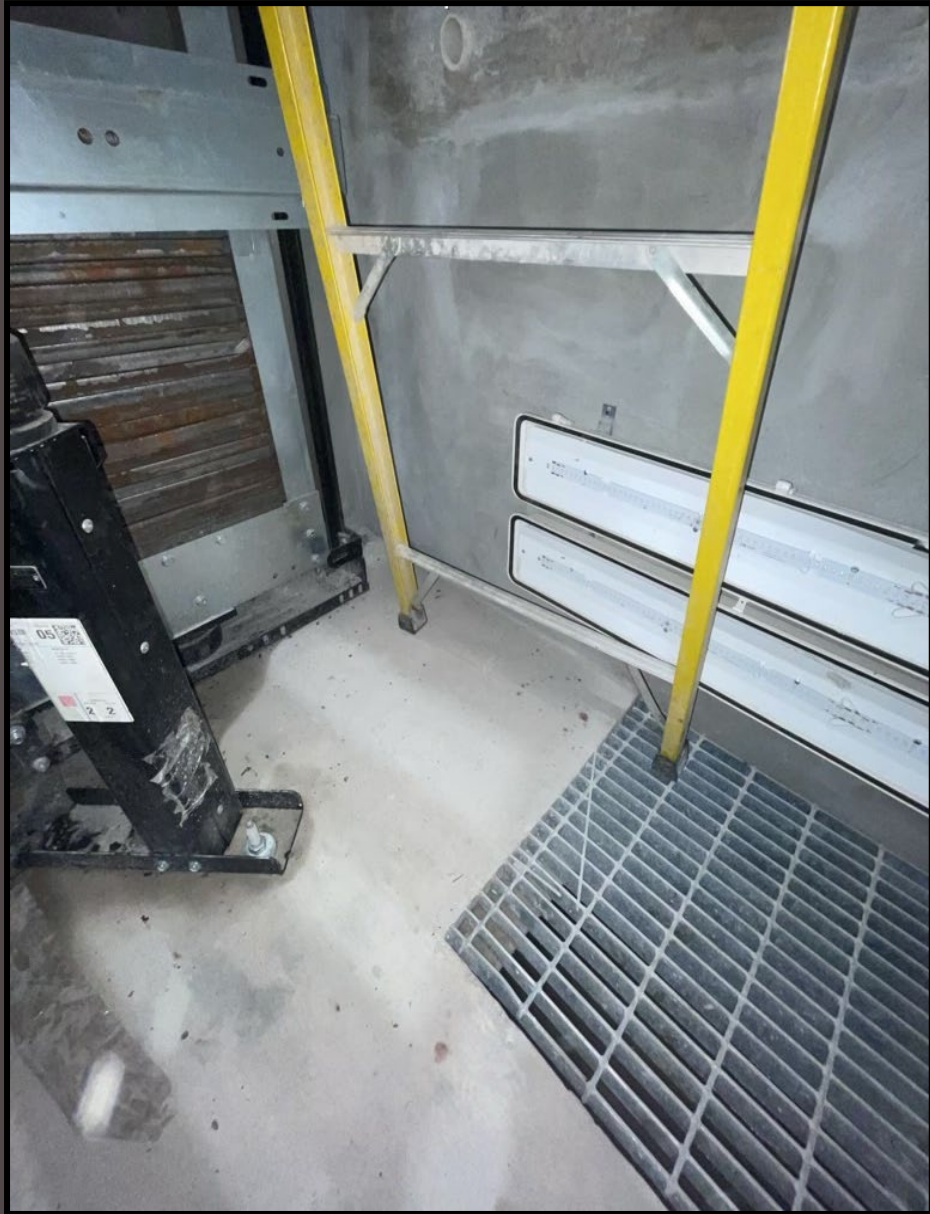
- An apprentice was loading a counterweight frame while standing on an 8-foot stepladder. The frame travels within a combination bracket, so it was necessary to place the ladder next to the main rail. After setting a filler weight in the frame the apprentice repositioned himself to receive another filler weight from the mechanic.
- The team was unaware that one of the ladder legs was on the sump pump grating. As the apprentice shifted his weight, the ladder became unstable, and he lost his balance. The apprentices' arm contacted the edge of the rail and slid downward causing a laceration about 2 inches long and ¼ inch deep.
- The apprentice was able to step off the ladder into the lobby and the mechanic administered first aid. The apprentice drove himself to the emergency room for treatment.

Physicians cleaned the laceration and four staples were inserted to close the wound. He was cleared to return to work the same day.

- Always follow the company safety policy
- Always perform a JHA/JSA per company policy

- Failure to follow the company policy on ladders
- The ladder was not on level ground

1926.1053(b)(6) Ladders shall be used only on stable and level surfaces unless secured to prevent accidental displacement.
