IUEC INCIDENT SUMMARY

CLOSE CALLS & INJURIES

CLOSE CALL

MAY 7, 2024

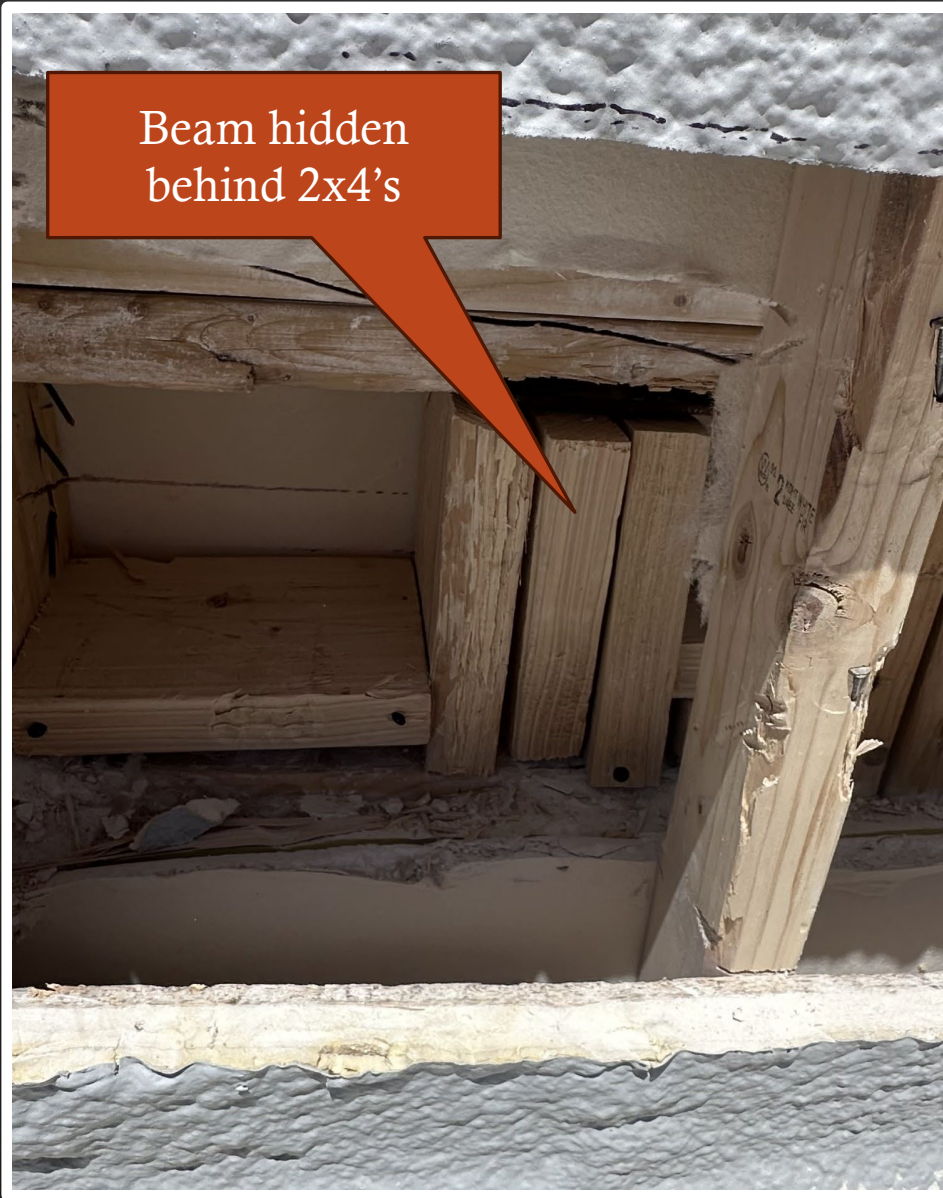
- A construction crew installed lifelines on the hoisting beam and were preparing to set up the rigging equipment on the same beam.
- An extension ladder was placed from the top landing to the back wall of the hoistway. The apprentice climbed the ladder, grabbed the hoisting beam, shook it and noticed it was not solidly attached.
- The beam attachment was enclosed by drywalled on the hoistway side and stucco covered the outside of the hoistway. The crew notified their superintendent and the General Contractor.
- The GC directed the framing crew who installed the beam to open the exterior wall to expose the beam. The beam had 2x4's wedged in place to prevent the beam from flipping. No lag bolts were installed as required by the engineered drawings.
- The framing crew confirmed their foreman directed them to use the 2x4's because they did not have the required lag bolts.

The beam was secured properly using 5/8" lag bolts as required. The other two hoistways on-site were inspected and found to be missing the 5/8" lag bolts. The problem was corrected on all hoistways.

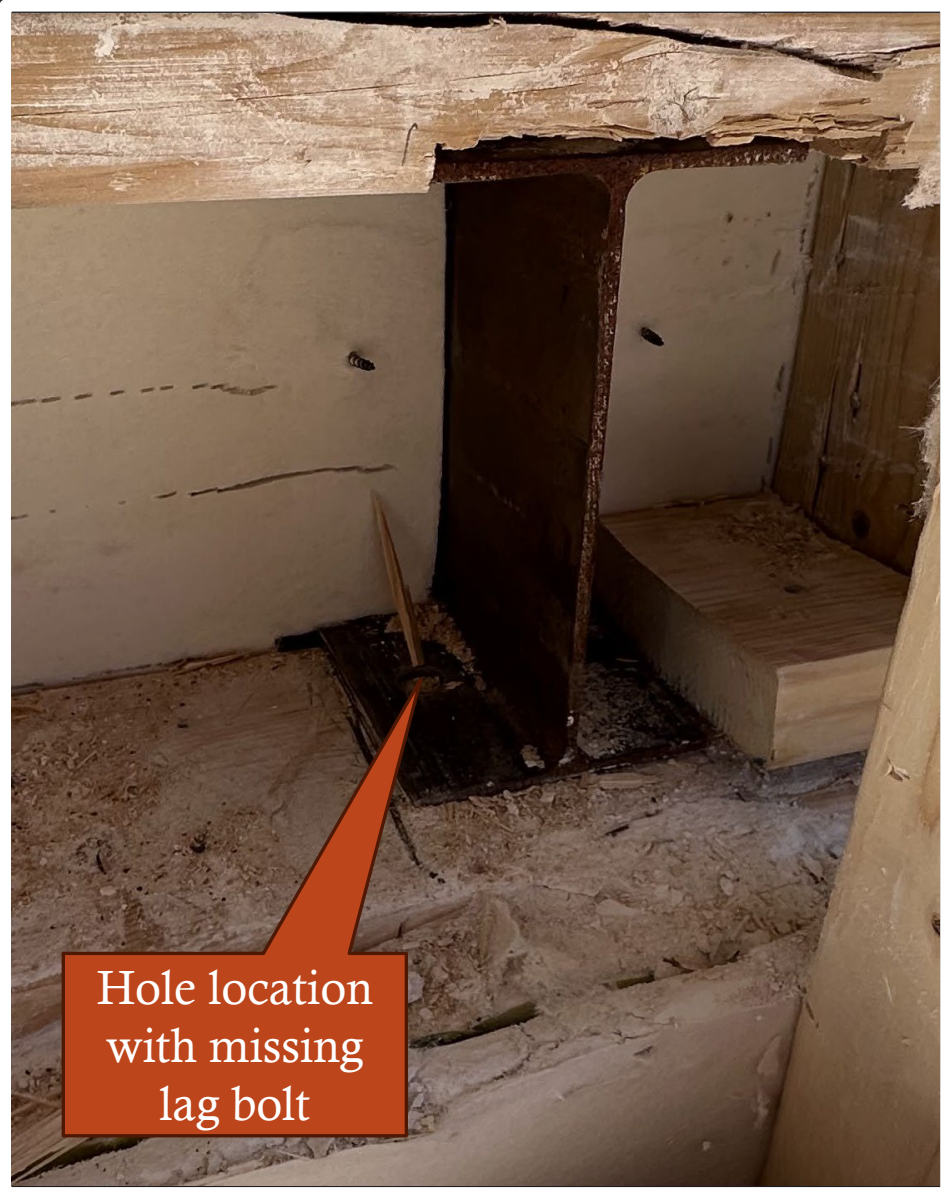
- No verification process of proper installation of hoisting beams

Hole location
with missing
lag bolt

- Always follow the company safety policy
- Always perform a JHA/JSA as per company policy
- Always verify anchorages for lifelines. Hoisting and rigging must be properly secured.
