IUEC INCIDENT SUMMARY

CLOSE CALLS & INJURIES

CLOSE CALL

JUNE 27, 2024

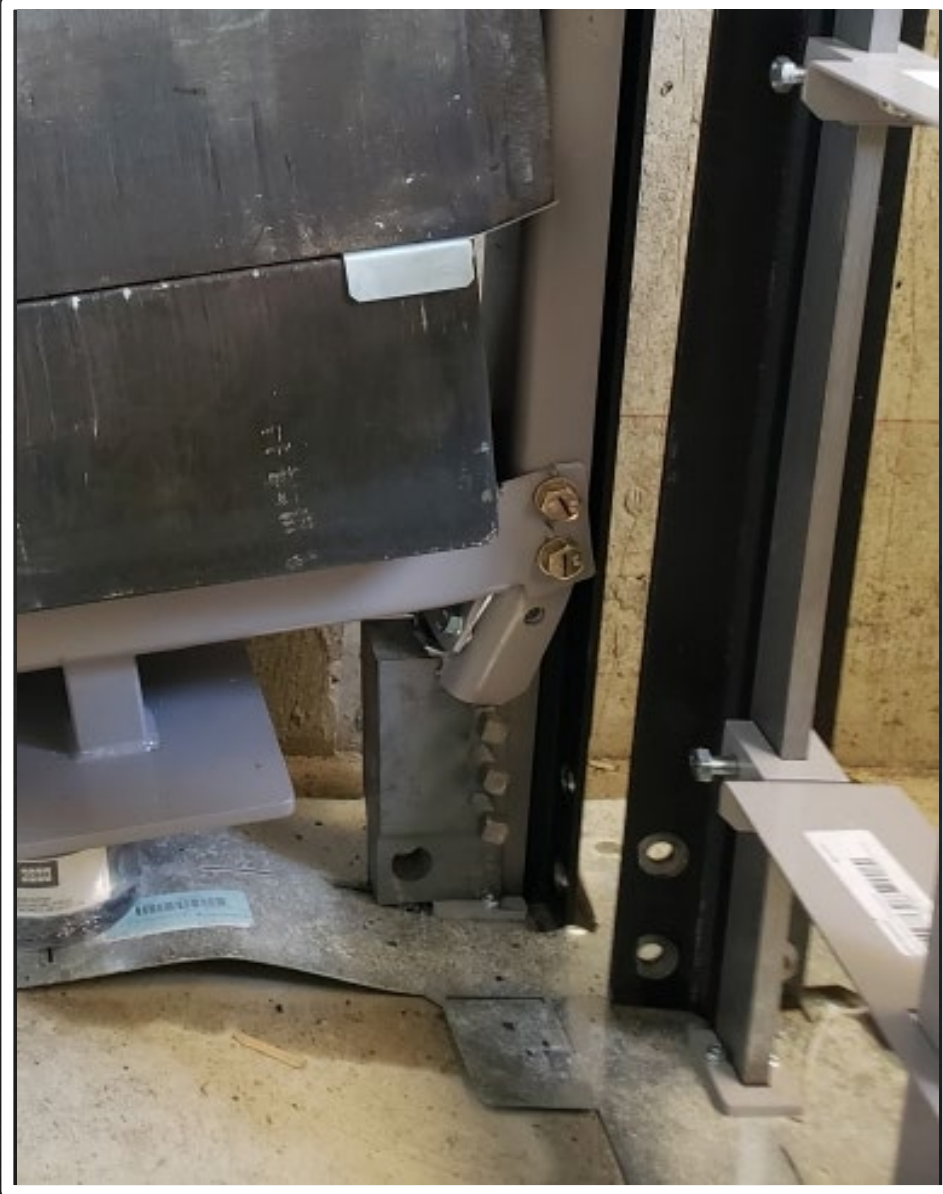
- A construction crew finished assembling the car and counterweight frame in the pit and had installed the cable-climbing device to begin work from the false car
- The crew ran the car up out of the pit so they could finish preparing the false car for use
- The apprentice was in the pit feeding the excess cable for the cable-climbing device to the mechanic when the mechanic instructed the apprentice to remove the rail blocks while he was under the car
- The apprentice was distracted and removed the rail blocks from beneath the counterweight rails causing the counterweight frame to crash into the pit, brushing against his face and arm

The apprentice sustained a scrape to his face and bruising to his arm. The counterweight frame will need to be replaced.

- Always follow the company safety policy
- Always perform a JHA/JSA as per company policy
- Always follow company SWPs

- Lack of concentration
- Distracted by other tasks
