IUEC INCIDENT SUMMARY

CLOSE CALLS & INJURIES

CLOSE CALL

SEPTEMBER 6, 2024

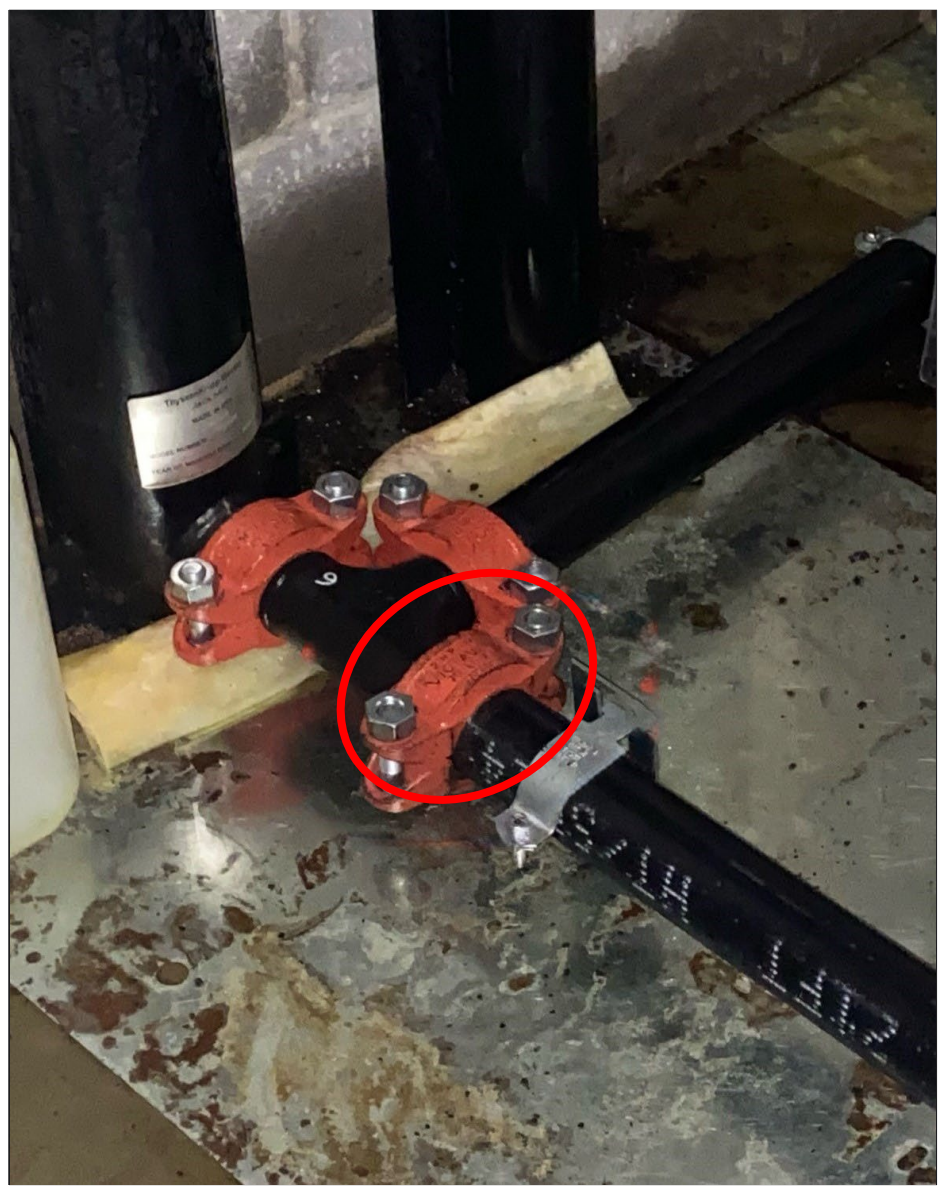
- A repair crew was performing a Category 1 test on a twin post hydraulic elevator
- When the car was run onto the stop ring to verify the 480 PSI relief setting, the system reached a pressure of 440 PSI before the pressure dropped and the car descended uncontrollably onto the buffer springs
- After the elevator was hoisted and placed on pipe stands a follow up inspection was performed. It was determined that a Victaulic seal had failed, and the likely cause was a loose Victaulic coupling.

The elevator pit was cleaned, all necessary repairs were made, and the hydraulic system was tested

- Always follow the company safety policy
- Always perform a JHA/JSA as per company policy
- Always follow Standard Work Practices

- Failure to inspect the hydraulic system for leaks or loose connections prior to performing a Category 1 test
