IUEC INCIDENT SUMMARY

CLOSE CALLS & INJURIES

INJURY

AUGUST 6, 2025

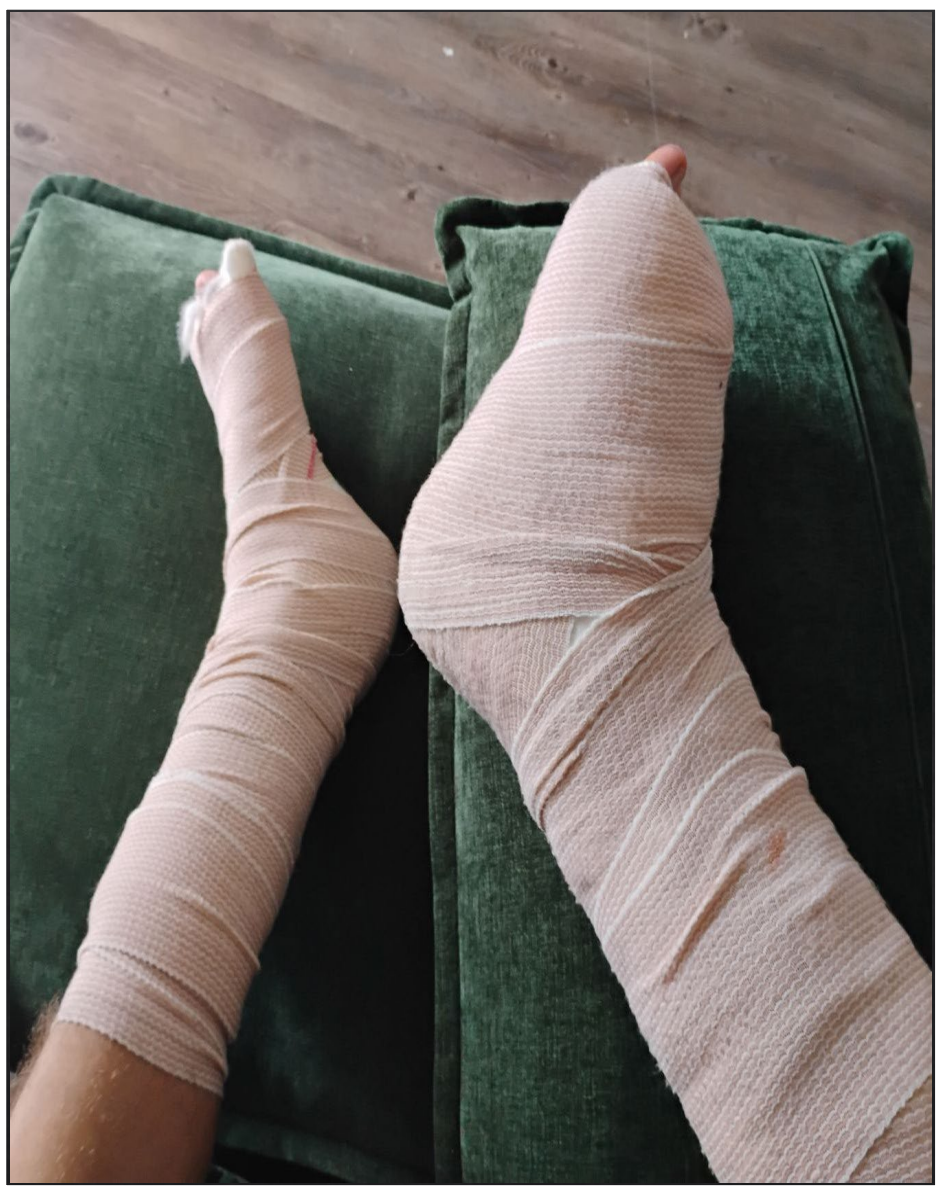
- A mechanic and a probationary apprentice completed the installation of CSBs on a new installation and removed the temporary hoist and suspension means
- As they were running down from the top landing using temporary run controls, the apprentice told the mechanic he no longer had control of the running platform
- The crew braced themselves as the car crashed into the pit
- An ambulance was called and the mechanic and apprentice were taken to a nearby hospital

The mechanic sustained a broken leg and cuts to his head. The apprentice shattered bones in his foot and a broke his ankle.
