IUEC INCIDENT SUMMARY

CLOSE CALLS, NEAR MISSES AND INJURIES

“NEAR MISS”

April 28th 2023---IUEC Safety Stand Down Day

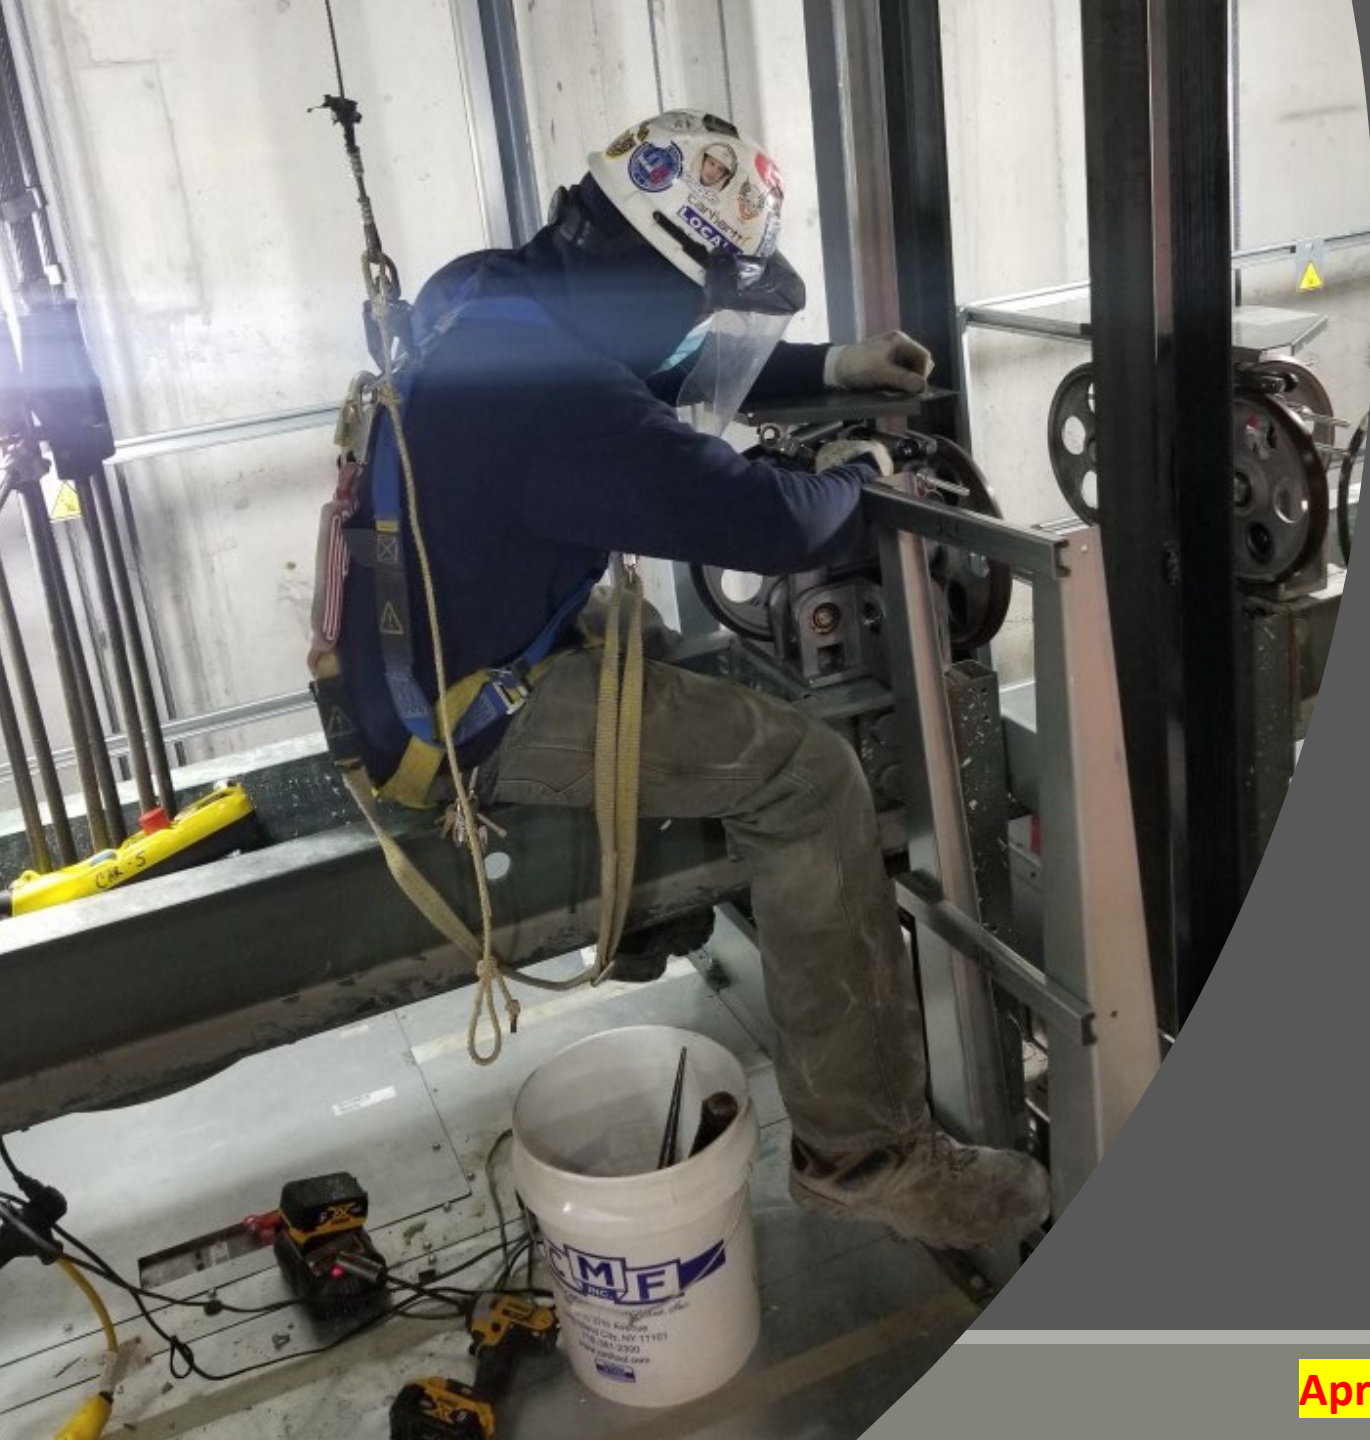
-
- A Modernization crew was working on the second car of a 2 car Mod job. The first car was completed by another crew, passed inspection, and was turned over to the hospital. While the second team was working on their car, they received a call from the hospital stating that the first car was running with the lobby doors open.
 - Upon inspection they found that the car was running with the slow speed door open. They discovered the GAL spring closer was detached and the slow speed door relating angle was not installed.
 - The doors were Peelle; two speed horizontal sliding doors
 - The doors had a plate that was tapped with three 5/16 holes to receive the GAL spring closer, and the plate was secured to the door by two pop rivets.
 - The rivets broke off and the bracket on the slow door became dislodged

- Possible Root Causes:
 - The Peelle doors were not manufactured properly
 - The rivets attaching the GAL spring closer adaptor plate failed and the closer fell off the door
 - The relating angle was not installed on the slow speed door

- Current status:
 - Peelle was contacted and they replaced all of the slow speed doors. They put the adaptor plate with the three 5/16 tapped holes on the inside of the door and attached it with rivets.
 - The new slow speed doors have been installed and the relating angle has been installed on the slow speed door
