IUEC INCIDENT SUMMARY

CLOSE CALLS, NEAR MISSES AND INJURIES

April 28th 2023---IUEC Safety Stand Down Day

Incident Report

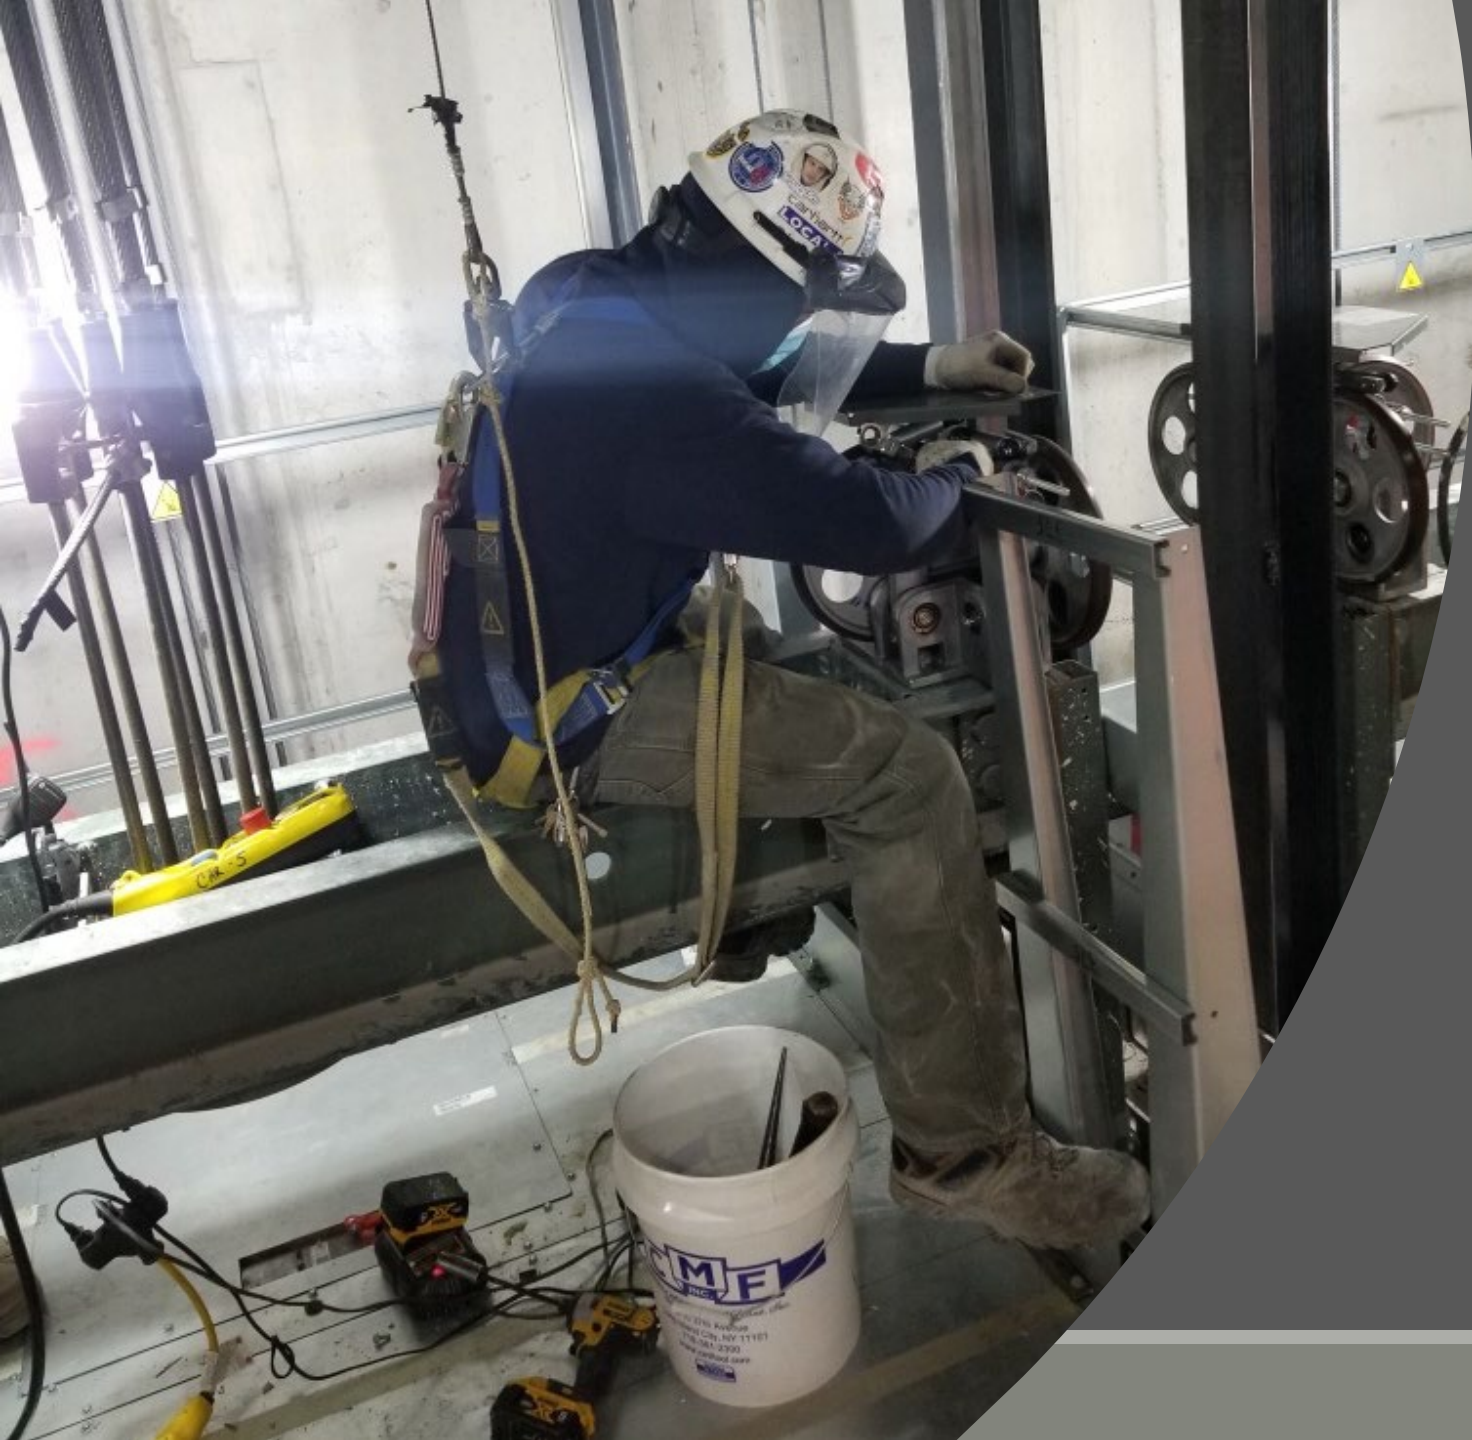
- A crew was installing a new cab on an elevator which is part of a duplex configuration. The cars have corner post rails, no divider beams, and 6 inches of clearance between the cars.
- The mechanic was working inside the car attempting to line up the new transom to the walls. The apprentice was on the landing leaning into the hoistway tightening the bolts on the newly installed transom and cartop.
- As the apprentice was performing his task, the adjacent car, which had not been taken out of service, came down to the 2nd landing (lobby floor) where the work was being performed.
- The adjacent car struck the apprentice in the back of his head; the impact caused him to hit his face on the elevator they were working on, leading to a laceration on his face.

- Always follow the company safety policy
- Always perform a JHA/JSA per company policy
- Possible root causes:
 - The team was told by the building and the General Contractor that the adjacent car was not to be shut off under any circumstances.
 - When performing work with an adjacent running car, clearances need to be such that employees are not at risk of injury. With the impossibility of screening between the two cars, measures need to be taken to ensure the safety of the worker.
- Field Employees' Safety Handbook
 - Section 7: Lockout and Tagout
 - 7.1 Procedures
 - (a) Understand the equipment; be aware of its potential hazards. If it is not understood, or if you have a question, contact your Superintendent/Manager immediately before proceeding.
 - Section 8: Hoistways and Machine Rooms
 - 8.3 Hoistway Screening

Where an elevator is operating in a multiple hoistway, and construction or modernization work is to be performed in an adjacent portion of that multiple hoistway, that portion of the elevator's hoistway where the work is to be performed shall be fully separated. The material used for this separation shall:
