# IUEC INCIDENT SUMMARY

CLOSE CALLS & INJURIES

INJURY

SEPTEMBER 3, 2024

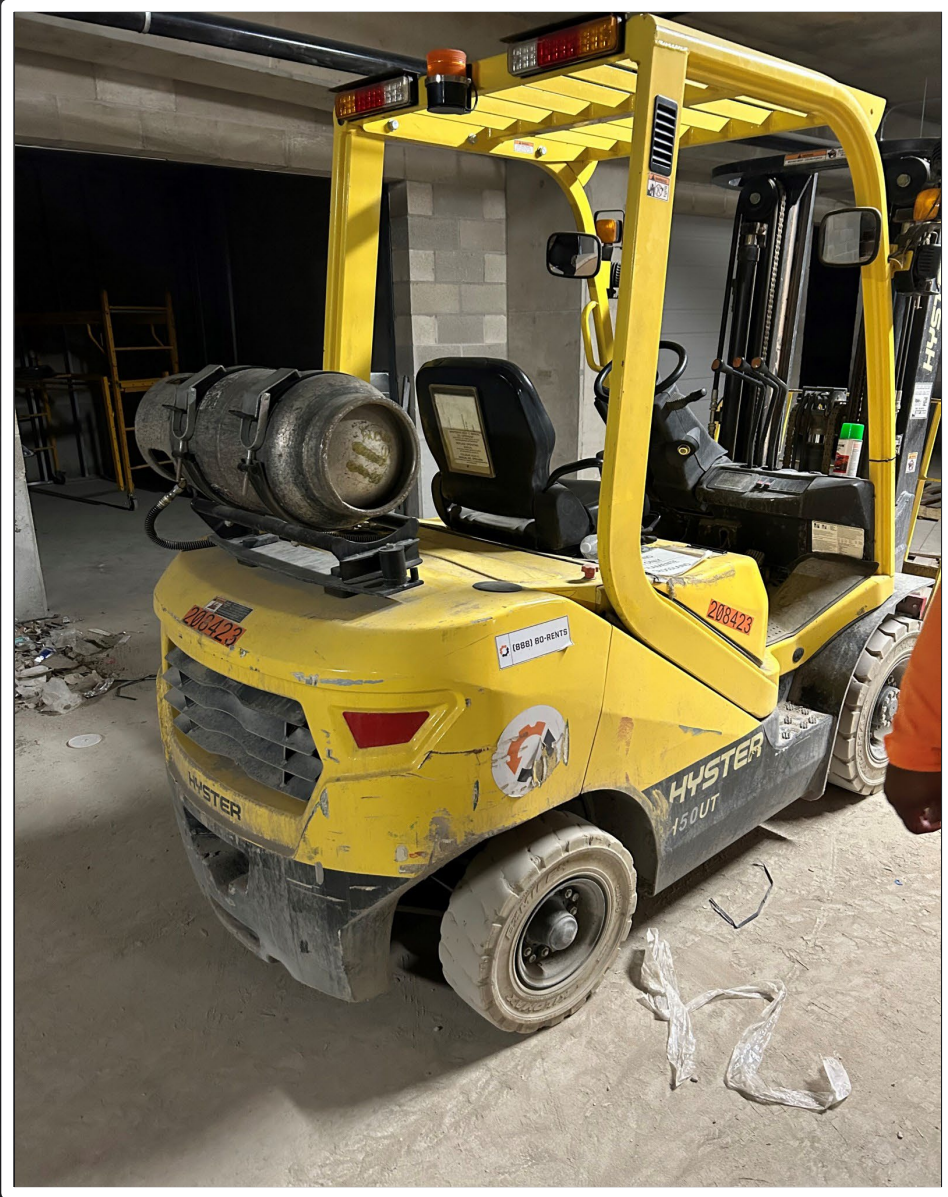
- Two mechanics used a forklift to transport hoisting and rigging equipment to the top floor of a parking ramp
- After discussing the next steps of installation, one mechanic started to walk back to the hoistway as the other was beginning to return the forklift to the lower level
- The walking mechanic turned around and approached the forklift from behind to give the mechanic further instructions
- The mechanic operating the forklift did not see the other mechanic approach and when he turned the forklift, the rear tire ran over his foot

The mechanic will be out of work for several weeks recovering from a fractured ankle

- Not establishing proper communication protocols

- Always follow the company safety policy
- Always perform a JHA/JSA as per company policy
- Never approach a vehicle from behind when it is in operation
