# IUEC INCIDENT SUMMARY

CLOSE CALLS & INJURIES

INJURY

OCTOBER 24, 2024

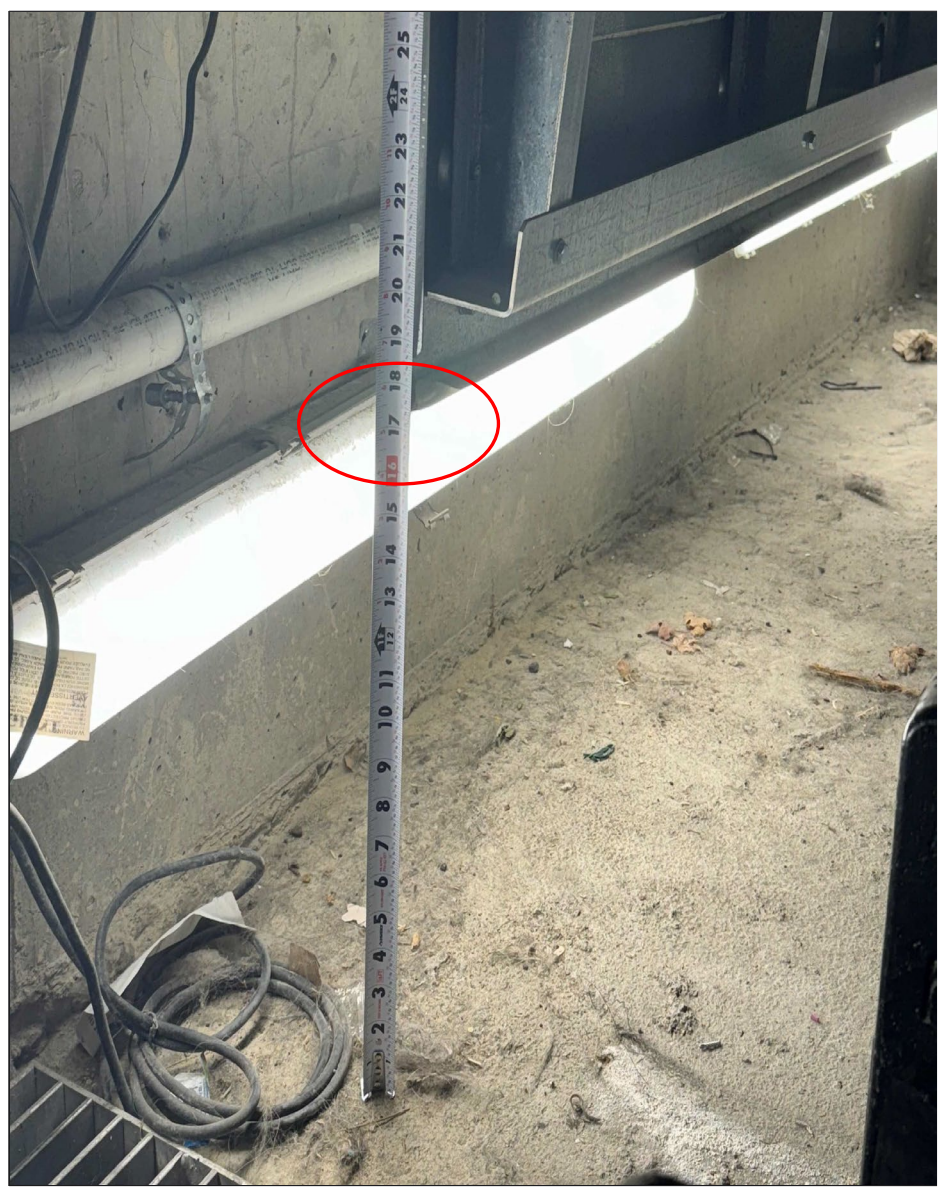
- Two maintenance mechanics were installing hold down brackets for filler weights when a piece of hardware fell into the sump well of a duplex pit
- One of the mechanics tried to remove the metal grating from the well when the coupling for the sump pump discharge line failed and water began spraying onto the mechanic
- The mechanic repositioned himself to reach for the hardware and was struck by the rear entrance toe guard of the adjacent car, knocking him down and pinning him to the pit floor
- The second mechanic was able to move the car, secure it, and help the first mechanic out of the pit and to the hospital

The mechanic suffered multiple sprains and strains to his knee, hips and back and will perform light duty work while recovering

- The sump well cover was not properly installed requiring disassembly of the discharge line for removal
- Failure to control both elevators when accessing a shared space

- Always follow the company safety policy
- Always perform a JHA/JSA as per company policy
- Separation of Adjacent Pits

(b) Before entering a pit, familiarize yourself with the position of the car and counterweights for the car being worked on as well as any other cars/counterweights in the vicinity.

(r) When in multiple hoistways, **never place any part of your body in the runway of an adjacent operational elevator.**
