IUEC INCIDENT SUMMARY

CLOSE CALLS & INJURIES

JANUARY 23, 2025

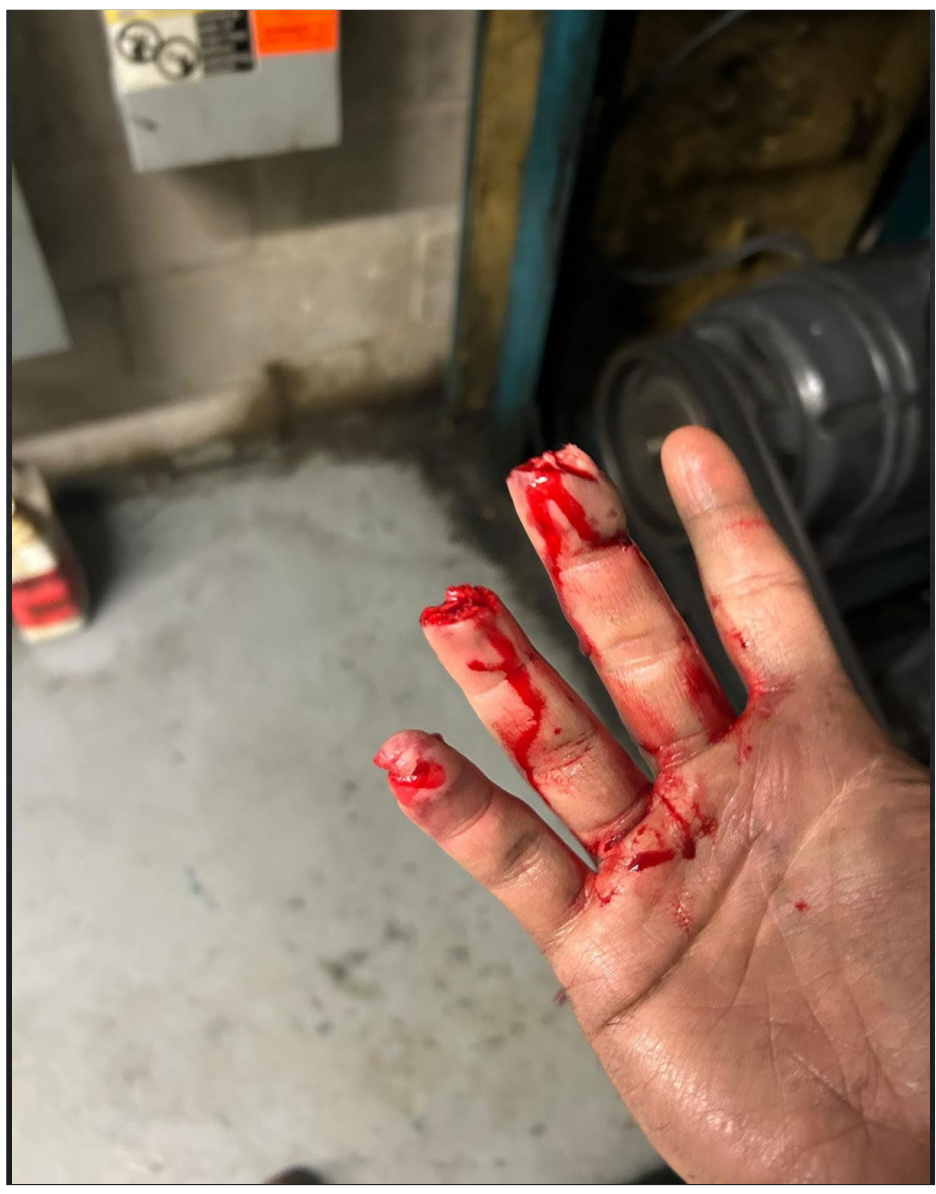
- While performing a Category 1 test, the mechanic noticed one of the pump motor V-belts was upside down
- The mechanic removed the elevator from service from within the controller and began to adjust the belt
- The elevator leaked down and when it releveled, the mechanic's hand was pulled in between the pulley and the belt

The tips of the middle and ring finger were amputated, and doctors were able to stitch the tip of the pinky finger in place to save it

Possible Root Cause:

- No Lockout and Tagout

Recommendations & Lessons Learned

- Always follow the company safety policy
- Always perform a JHA/JSA as per company policy

(b) Where the accidental starting of the equipment would create a hazard – deactivate mainline disconnect switch to shut off the power. **CAUTION:** Do not stand directly in front of the mainline disconnect when operating (stand off to the side of the disconnect). Each employee shall apply to the disconnect switch a personal lock and a “Do Not Start” tag with the employee’s name (Section 5.3).
