# IUEC INCIDENT SUMMARY

CLOSE CALLS & INJURIES

INJURY

MAY 5, 2026

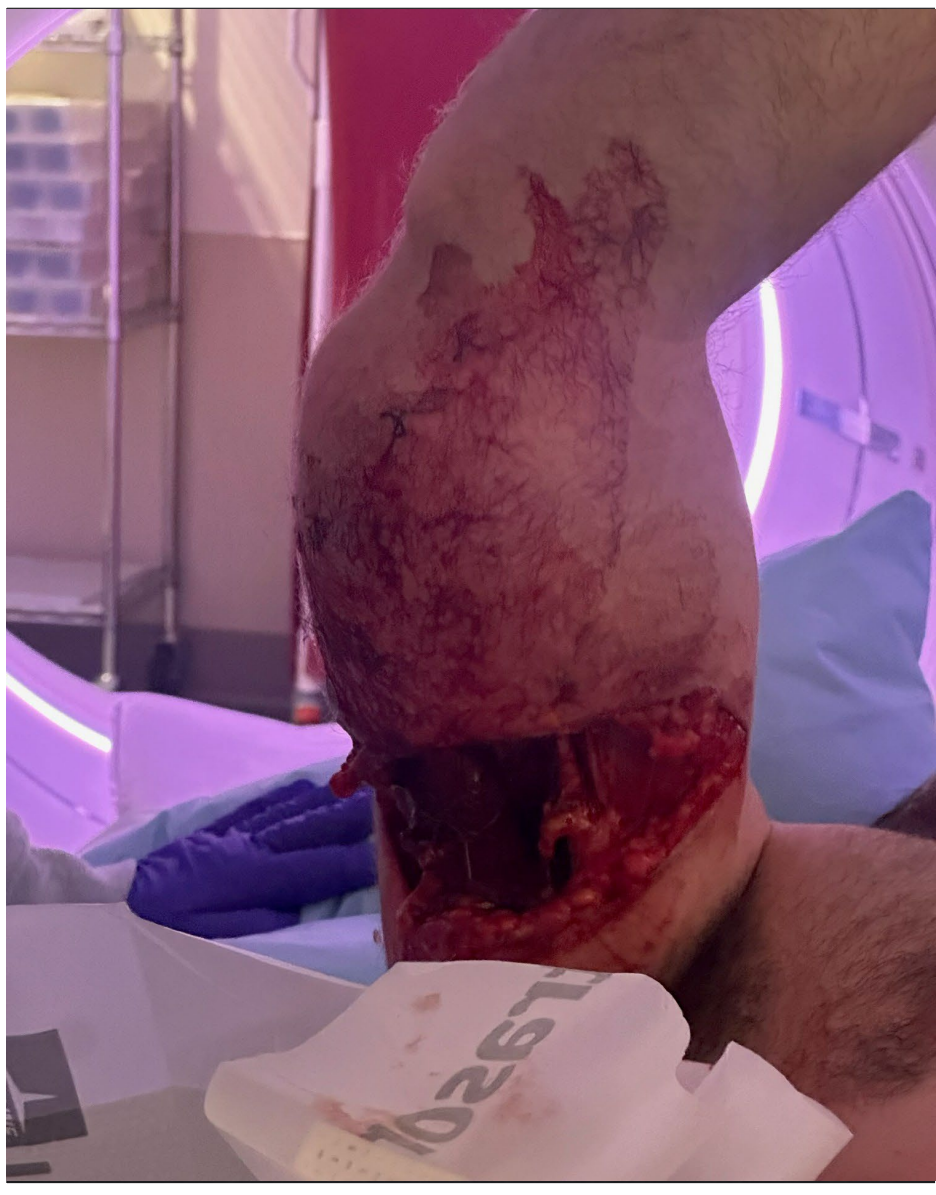
- The modernization crew parked car 1 on the 9<sup>th</sup> floor using Independent Service so they could work in the pit
- The apprentice was handing tools and materials from the 1<sup>st</sup> floor landing to the mechanic who was standing on an 8' step ladder in the pit
- The apprentice was instructed to close the hoistway doors and take car 2 to the top floor and get more wire connectors
- When the doors to car 1 closed the elevator went into Phase I Fire Recall and came down onto the mechanic trapping his arm between the car and hoistway sills before he could get off the ladder

Investigation found faulty wiring had caused the Phase I FS recall. The mechanic sustained severe injuries to his upper arm and remains out of work during a hopeful recovery

- The car being worked on should have been locked out and tagged out prior to beginning work

- Always follow the company safety policy
- Always perform a JHA/JSA as per company policy
- Never enter a hoistway without having complete control of the movement of the elevator
