# IUEC INCIDENT REPORTS

CLOSE CALLS , NEAR MISSES AND INJURIES

# Incident Report

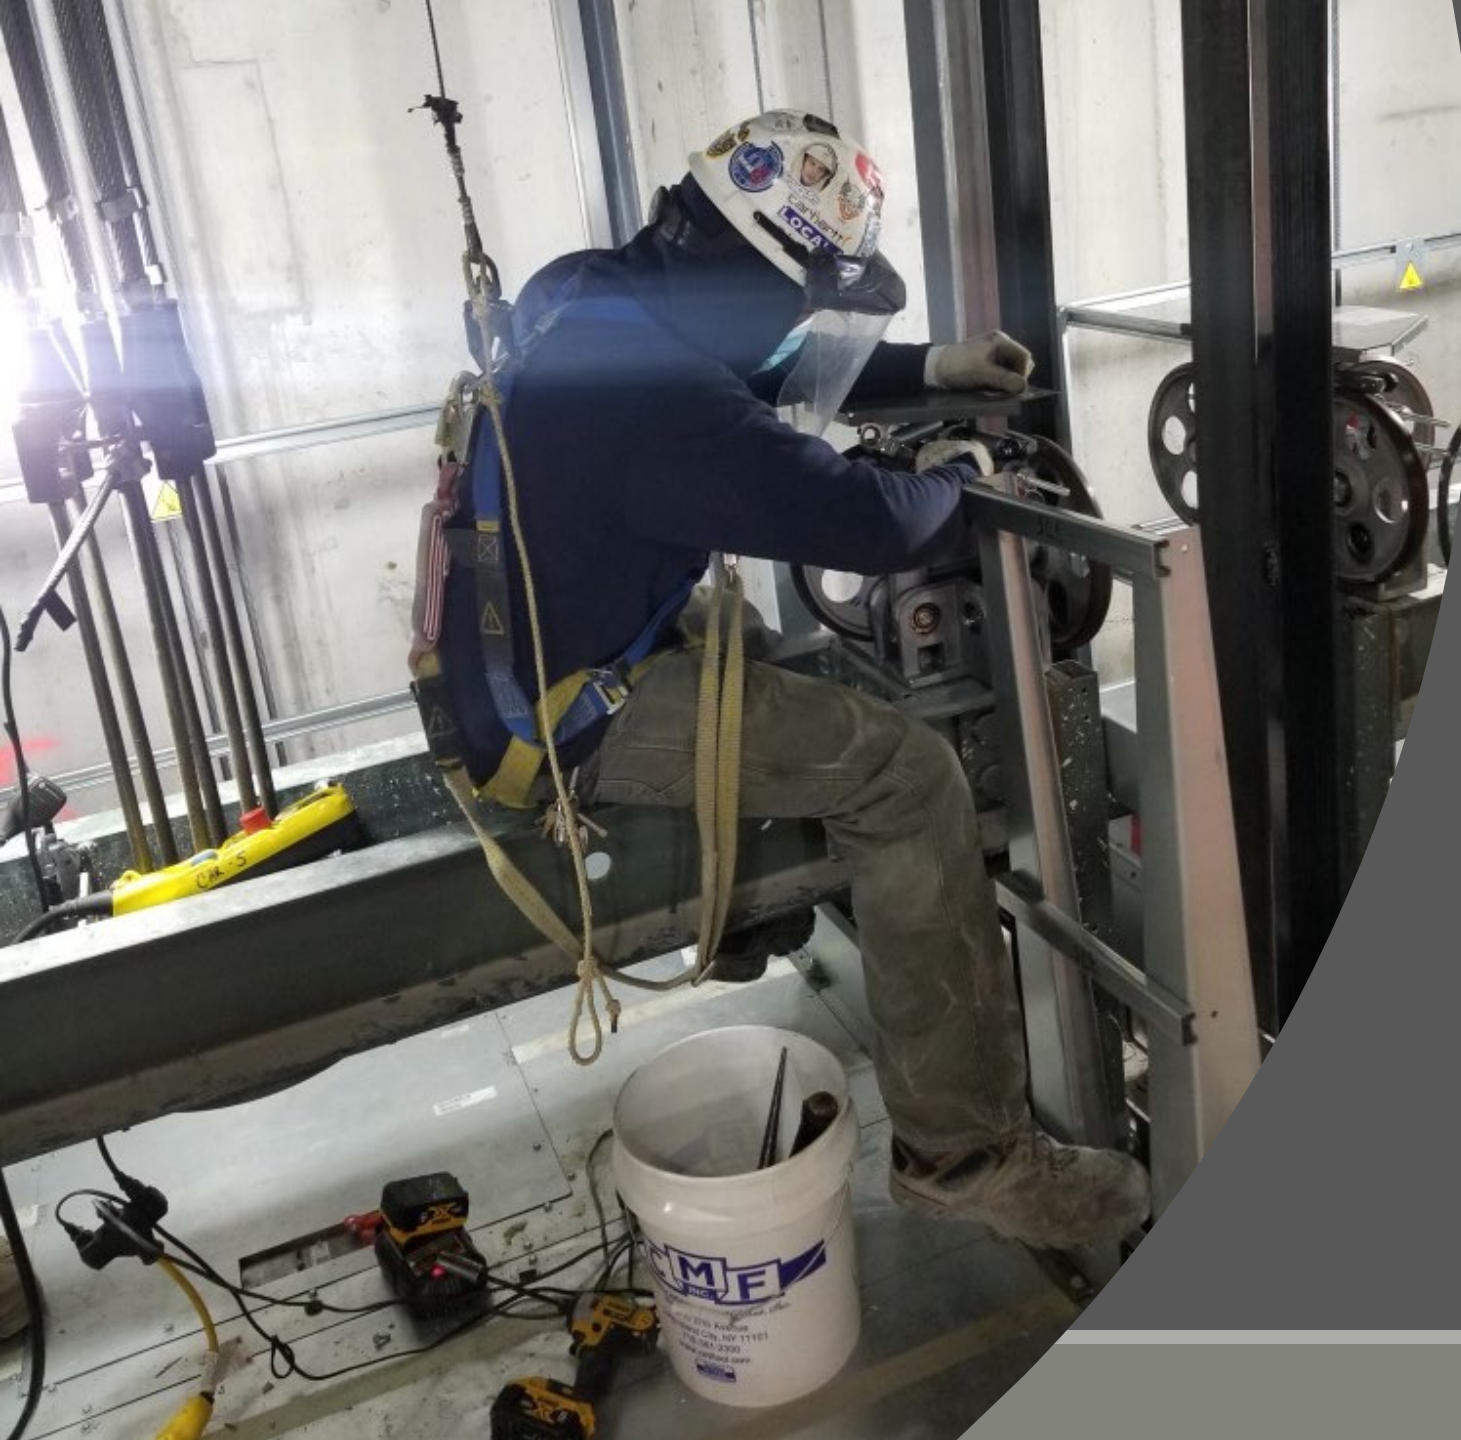
- A mechanic and an apprentice were piping the bottom terminal limit.
- The mechanic was working from a ladder and the apprentice was kneeling on the car top, leaning over, handing tools and hardware down to the mechanic.
- The mechanic completed the task and handed the apprentice the tools to place back on the car top.
- When the mechanic was off the ladder and clear, the apprentice ran the car down to pick up the mechanic. The mechanic noticed the apprentice had something dripping down his leg.
- The apprentice looked at his knee and saw a hole in his pants. The apprentice lifted his pant leg and saw he had a laceration to his knee.
- The apprentice remembers bumping his knee on the door restrictor flag and that is where he believes he received the laceration.
- The apprentice received six stitches to his knee.

- Always follow company safety policies
- Always perform a JHA/JSA according to company safety policy
- Sharp edges on door restrictor flags mounted to hoistway doors must be de-burred.
- Be aware of your footing and walking/working surfaces while performing tasks.
