IUEC INCIDENT SUMMARY

CLOSE CALLS, NEAR MISSES AND INJURIES

“INJURY”

April 28th 2023---IUEC Safety Stand Down Day

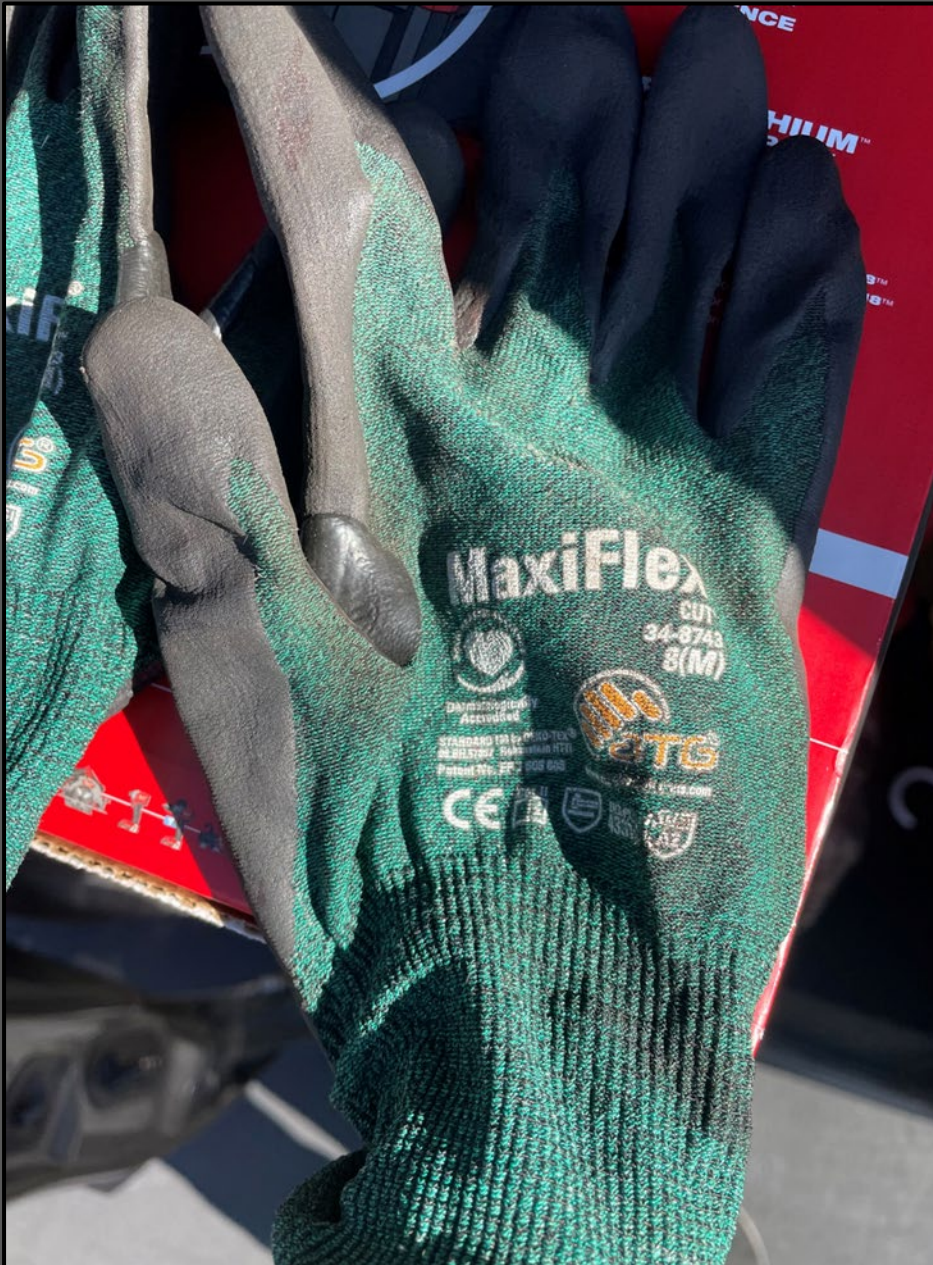
- A repair team was installing counterweight rods in the counterweight frame after adding weights to balance the car
- The rod was hung up and would not go all the way down
- The mechanic twisted the rod to free it up when suddenly the rod dropped pinching his pinkie finger
- When he removed his glove, he saw damage to his finger and sought medical attention
- The mechanic went to an urgent care facility where he received eight stitches to repair his finger
- Current status:
 - The mechanic returned to work and there was no lost time

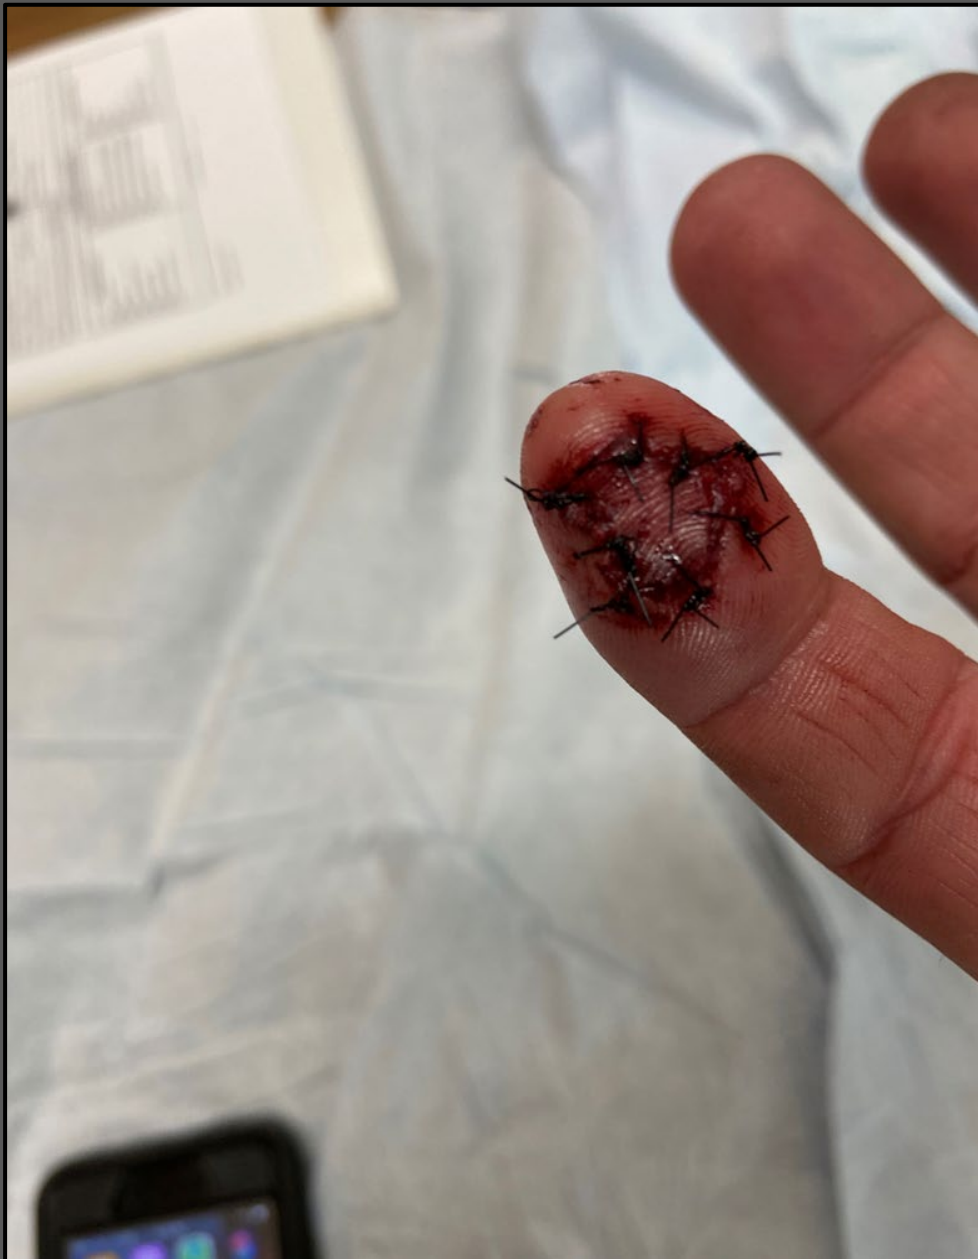
- Possible Root Causes
 - The repair team did not perform a JHA/JSA
 - The mechanic put his hand in a pinch point

- Always follow the company safety policy
- Always perform a JHA/JSA per company policy
- Always follow the SOP

- Identify potential pinch point hazards prior to starting work. Maintain stable footing and be properly braced while performing work.
- Be aware of the position of hands, fingers and feet at all times
- Gloves should not be worn in proximity to moving machinery or exposed pinch points. Employees will follow the manufacturers recommendation regarding the use of gloves while operating power tools and equipment.
