IUEC INCIDENT SUMMARY

“INJURY”
CAUGHT BETWEEN

April 28th 2023---IUEC Safety Stand Down Day

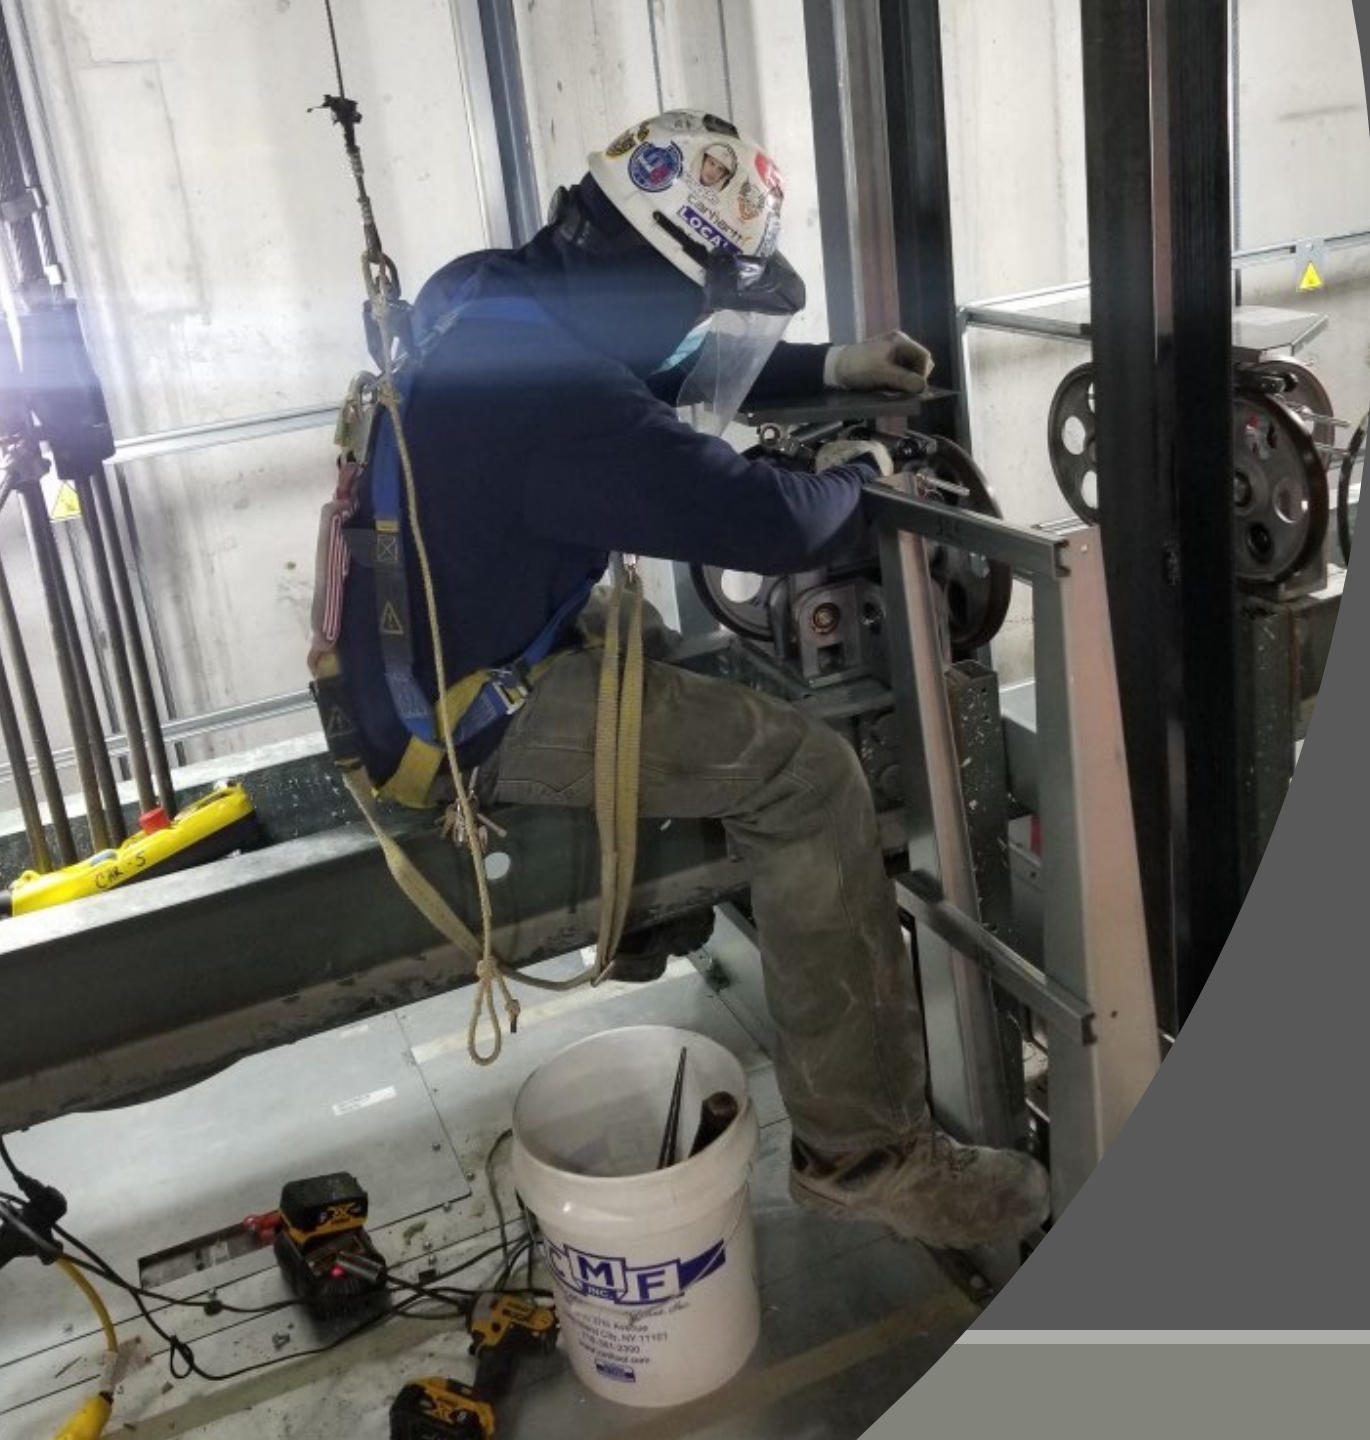
- A temporary mechanic was performing maintenance on a job that was not on his route. When he completed his work in the machine room, located at the first floor, he tried to exit but the door closed and locked behind him, and he could not get out.

- The door lock mechanism is old so unless you turn the key three times counterclockwise and hit the button on the jamb edge, the knob does not turn to open the door from either side. The TM tried to alert someone by knocking on the door, but no one heard him.

- Next, he decided to remove the hoistway screening so he could climb down onto the machine and access the pit ladder to exit the pit thru the hoistway door. Unfortunately, he did not perform lock-out-tag-out.

- As he was looking into the hoistway while standing on the gearbox, he slipped and fell face first into the hoistway over the hoist machine drive sheave. His left foot became wedged between the hoist machine drive sheave and the hoist ropes with the car running in the up direction. The TM yelled for help and the Sheriff's office in the building heard him. The Sheriff opened the hoistway door and saw him hanging upside down. They held his body upright for 2 hours while waiting to be rescued.

- Always follow the company safety policy
- Always perform a JHA/JSA as per company policy
- **Possible Root Causes:**
 - Non code compliant machine room door lock

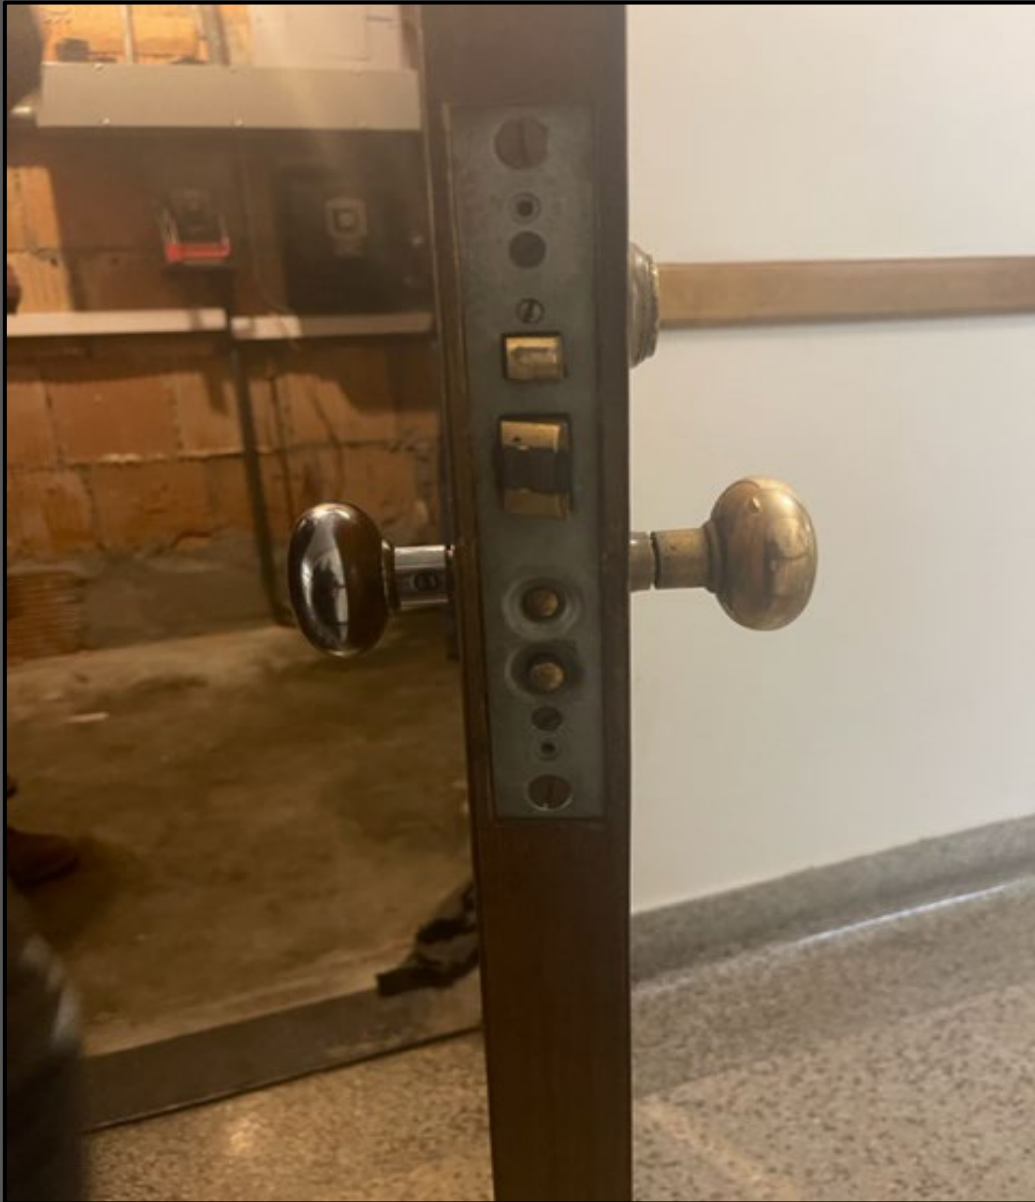
- Lock out tag out not utilized
 - Employee not familiar with the job
- **Field Employees' Safety Handbook**
 - Section 7 Lockout and tagout General requirements

- 7.1 Procedures
 - (a) understand the equipment; be aware of its potential hazards. If it is not understood, or you have a question, contact your Superintendent/Manager immediately before proceeding.

- (b) Where the accidental starting of the equipment would create a hazard – deactivate mainline disconnect switch to shut off power. **CAUTION: Do not stand directly in front of the mainline disconnect when operating (stand off to the side of the disconnect). Each employee shall apply to the disconnect switch a personal lock and a “DO NOT START” tag with the employee’s name.**

- Section 8.5 Machine Room Safety
 - (c) Machine room doors are typically self-closing and/or self-locking.
- **ASME A17.1**
 - Requires the door to be operable from inside the machine room without the need to use a key
