IUEC INCIDENT SUMMARY

CLOSE CALLS & INJURIES

INJURY

MAY 5, 2025

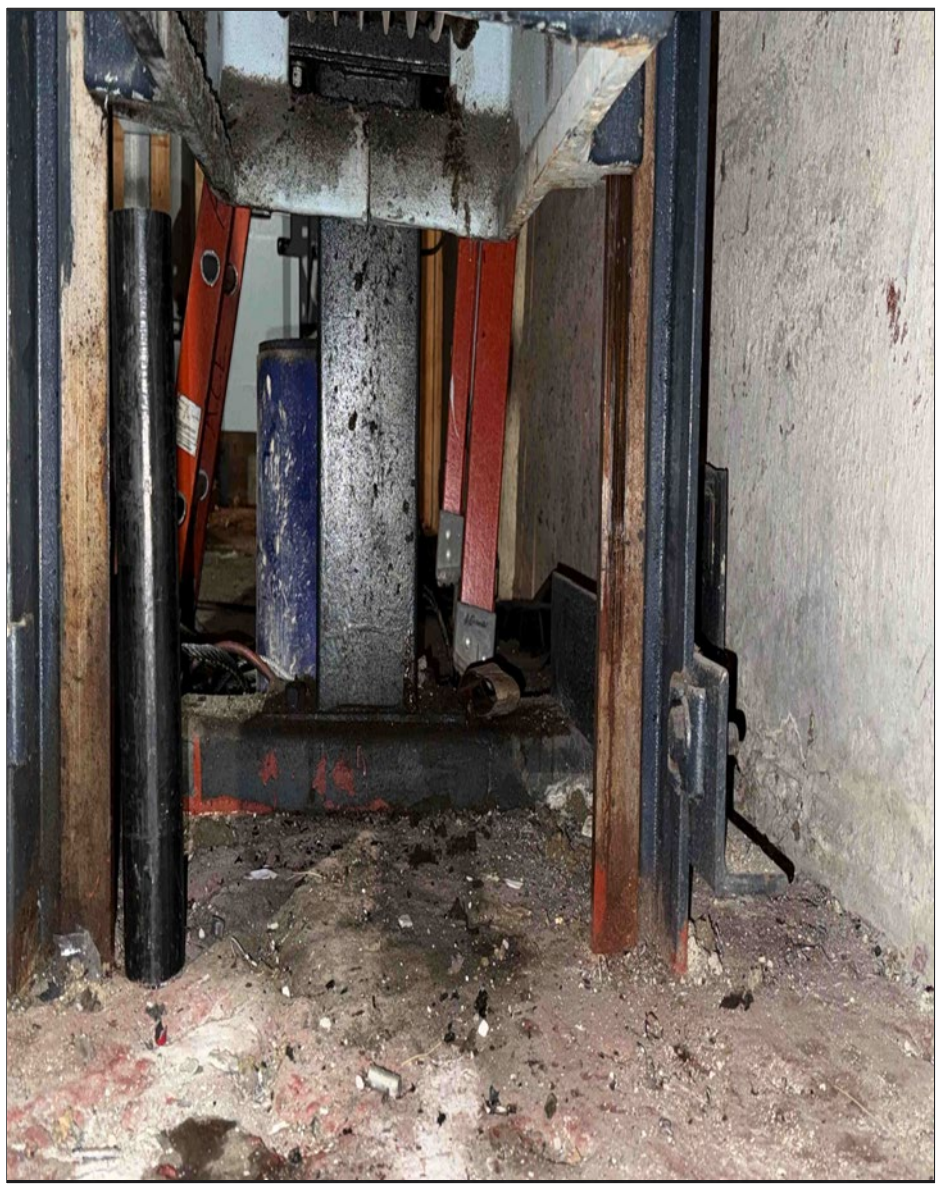
- A modernization crew was replacing hoist ropes on an elevator with compensation
- To do so, they detached the compensating ropes from the counterweight frame and used short steel pipe stands to support the compensating sheave
- Once the hoist ropes were replaced, the apprentice, forgetting the compensating ropes were detached, used a bottle jack to raise the sheave and remove the pipe stands
- After removing the pipe stands the apprentice realized the error and tried to jack the sheave back up to replace the pipe stands
- The bottle jack toppled over, and the sheave fell on the apprentice's hand pinning him to the pit floor
- The remaining crew used pry bars to lift the sheave and free the apprentice

- The rigging plan did not include a secondary means to support the compensating sheave while the cables were removed

- Always follow the company safety policy
- Always perform a JHA/JSA as per company policy

(b) Always stay clear of the load. Do not stand under the load. Know the weight of the load, the capacity of your equipment, the structure to which you are rigging and the overall condition of these items. Stand uphill or to the side of a load that's on a ramp.
