IUEC INCIDENT SUMMARY

INJURY

FEBRUARY 11, 2026

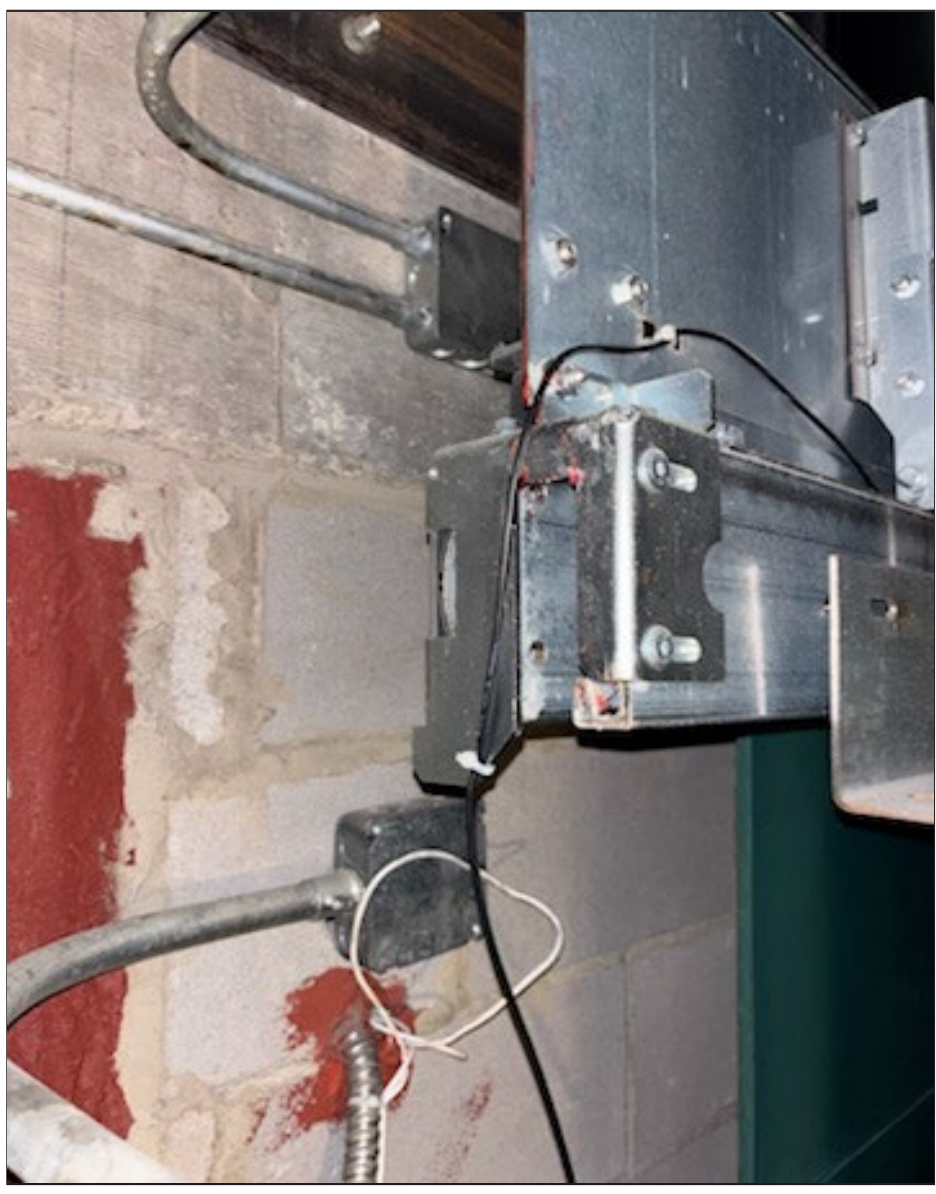
- A repair team was installing door position switches for an infant security system on the 13th floor of a hospital
- They had to pull wiring from the hoistway into the drop ceiling in the lobby from the cartop
- The mechanic reached into the adjacent hoistway of a running elevator to push the wiring through the wall
- The header of the running elevator caught his hand and pulled it down until his arm hit the divider beam, breaking his hand free

The mechanic required immediate surgery to repair a compound fracture and torn tendons on his right hand. He will have a long recovery.

- Always follow the company safety policy
- Always perform a JHA/JSA as per company policy
- Never work in hoistways without controlling the elevators
- Stop work when necessary to provide for safe working conditions

- Pressure to leave the adjacent car in service
- Pressure to complete the task without changing the time schedule
