# IUEC INCIDENT SUMMARY

CLOSE CALLS & INJURIES

INJURY

JUNE 22, 2026

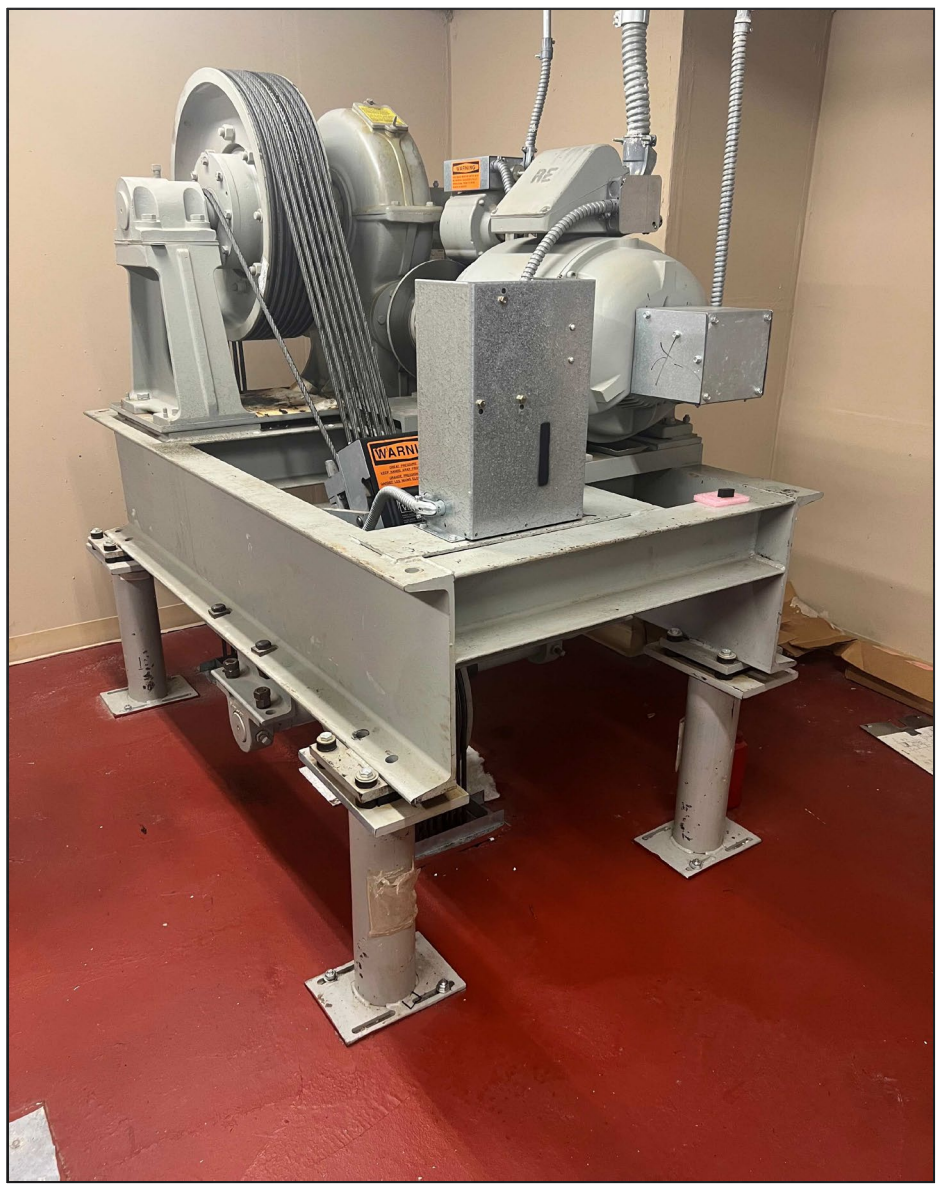
- 
- A maintenance mechanic removed the elevator from service to clean the hoist ropes
  - The mechanic placed the car on auto run in the controller so it would run top to bottom while he used a rag to clean the hoist ropes
  - The rag became caught in the hoist ropes and pulled his right hand into drive sheave
  - The mechanic's left hand was also injured while he tried to free his right hand from between the drive sheave and the hoist ropes

The mechanic remains out of work while recovering from multiple injuries to both hands

- No lockout and tagout
- The elevator was not secured against movement prior to beginning the task

- Always follow the company safety policy
- Always perform a JHA/JSA as per company policy

- (i) When movement of the equipment presents a safety hazard while performing tasks on any parts that move, the equipment shall be made inoperative by use of lockout and tagout or alternative means of control. (Refer to Section 7.)
- (o) Never use wiping cloths on or near moving and/or rotating equipment.
